AUDITOR
GENERAL'S
OFFICE

KEY FINDINGS OF PERFORMANCE AUDIT ON FUVAHMULAH CITY WATER AND SANITATION PROJECT

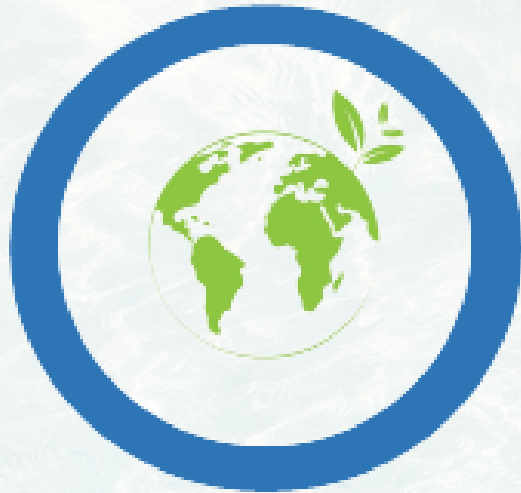
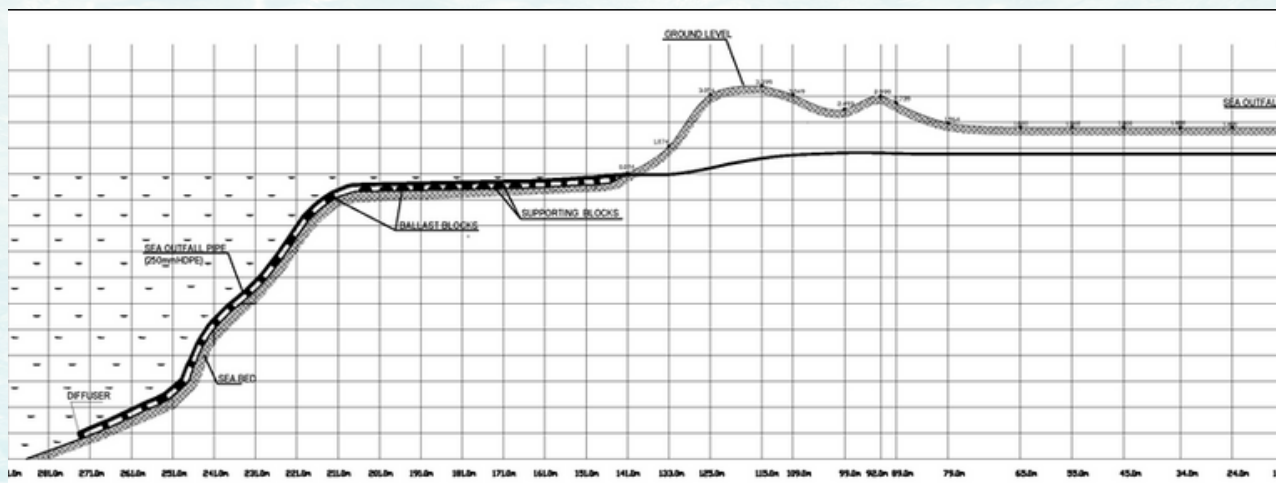
Works of the project have not been carried out in compliance with the Environmental Impact Assessment (EIA) report. The sewerage discharge pipe was constructed in an ecologically significant marine area, leading to the dispersal of sewer effluents into the aforementioned site. This was not the area designated in the approved EIA for the outfall construction. It should be highlighted that the site has later been declared as an Environmental Protected Area. .

Additionally, the discharge pipe was not installed at the depth specified in the EIA. As stated in EIA report, 15m depth is required for maximum environmental benefit and minimize environmental impacts which may arise due to the discharge which although treated will be a secondary treated waste product.

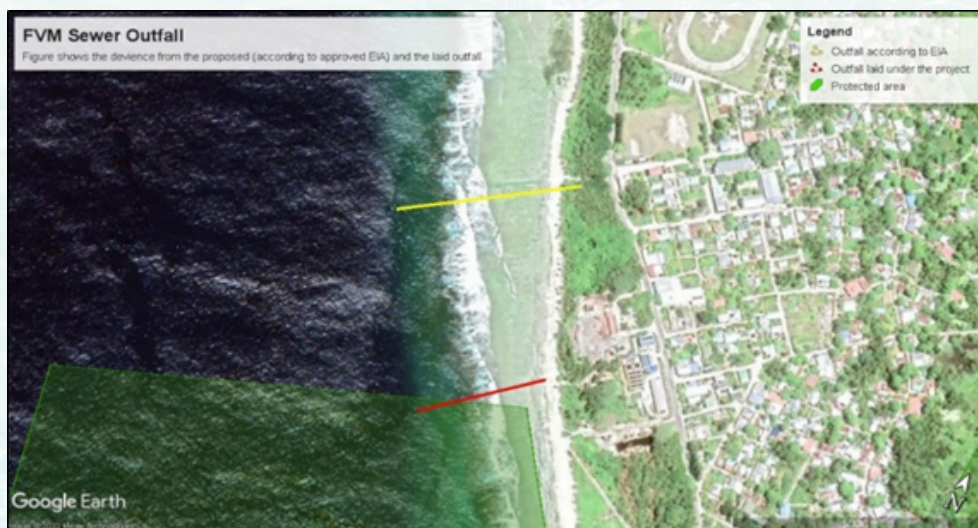
In addition, the establishment of some of the sewerage Infrastructure (STP, Vacuum station 1) were in an area other than which was specified in the approved EIA. Further, the approval for the revised areas was not provided to the Audit.

Due to the change of these sites, a significant increase in vegetation removal has occurred through the project. While in the EIA the impact for the initial vegetation clearance was classified as a medium to long term impact, the impact on the environment from clearing the vegetation is likely to be more than anticipated in EIA.
