**AUDITOR-GENERAL'S
PERFORMANCE AUDIT REPORT
ON CONSERVATION OF
WATER TOWERS IN KENYA**
BY THE KENYA WATERS TOWERS AGENCY

SEPTEMBER 2023

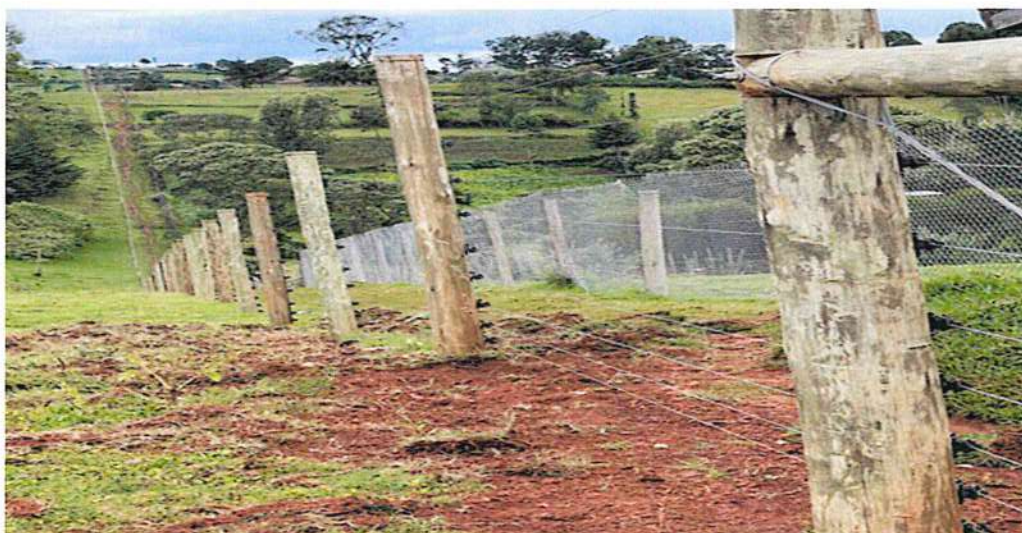
Picture 1: Erected Boundary Fence Along Maasai Mau

- 4.6 According to the Maasai Mau Phase II Action Plan, the Agency had targeted to construct an electric smart fence along the Maasai Mau Block covering the entire 119km boundary within two (2) years, starting from August 2019. However, only 30km of the fence had been constructed as at the time of audit in 2022. The fence was to provide a barrier for uncontrolled human access and real time monitoring of activities along the fence. The constructed fence observed during the audit inspection was as shown in **Picture 1**.

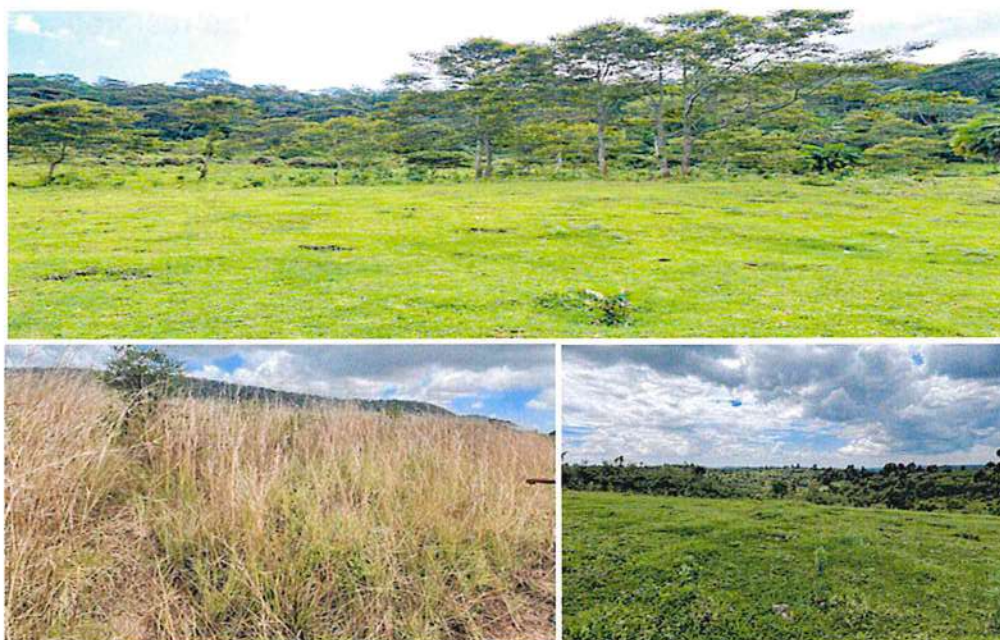
Picture 2: Status of Reforested Sites in Nyambene, Shimba Hills and Maasai Mau

- 4.44 Further, document review revealed that the Agency's recommended seedling survival rate was 80% for a reforestation intervention to be considered successful. However, review of seedling audit reports availed for audit revealed that five (5) out of the seven (7) planted sites recorded survival rates lower than 80% as shown in **Table 7**. This is despite the Agency spending approximately Ksh.174million on tree planting activities towards the 10% National Tree Cover Campaign during the period 2019/2020 to 2021/2022. For instance, out of the seven (7) sites whose seedling audit reports were availed for audit, only two (2) had a survival rate of 80% and above. Block 67 in Maasai Mau recorded a very low survival rate of 39.4%.

4.45 The low seedling survival rates in reforested areas were also observed during audit inspection. For example, patches of bare land were observed in sites that the Agency claimed to have reforested in Nyambene Hills, Shimba Hills and Maasai Mau forest as shown in **Picture 2**.

- 4.50 Interviews and document review revealed that the suppliers engaged by the Agency sourced seedlings far from the sites being rehabilitated. The seedlings were not given time to acclimatize with the area before planting, hence leading to low survival rate of the planted seedlings. Interviews and document review also revealed that the recommended height of a seedling should be between 1ft and 1.5ft. However, interviews with staff of the Agency and review of documents revealed that the seedlings delivered were often below the recommended height. In addition, review of documents revealed that seedlings were sometimes delivered either when the rains were about to subside or after the rainy season, hence could not survive without watering.

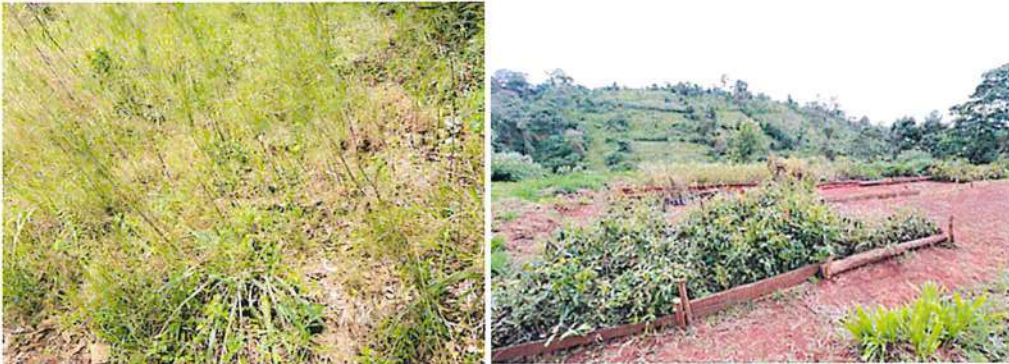
Picture 3: Status of Community Owned Nurseries

- 4.51 The audit noted that the Agency had started promoting local level seedling production by supporting selected community groups with tree nursery implements, including seeds. The arrangement was that the groups should produce seedlings and sell them to the Agency at a subsidised price. The seedlings were to be used for rehabilitation in the neighbouring water towers. However, physical verifications of such nurseries revealed low production capacity and poor nursery management. Besides, the seedlings looked overgrown as shown in **Picture 3** yet the Agency was supposed to procure from the community once the seedlings are mature. The groups reported that other than nursery implements, the Agency did not provide them with training on tree nursery management.

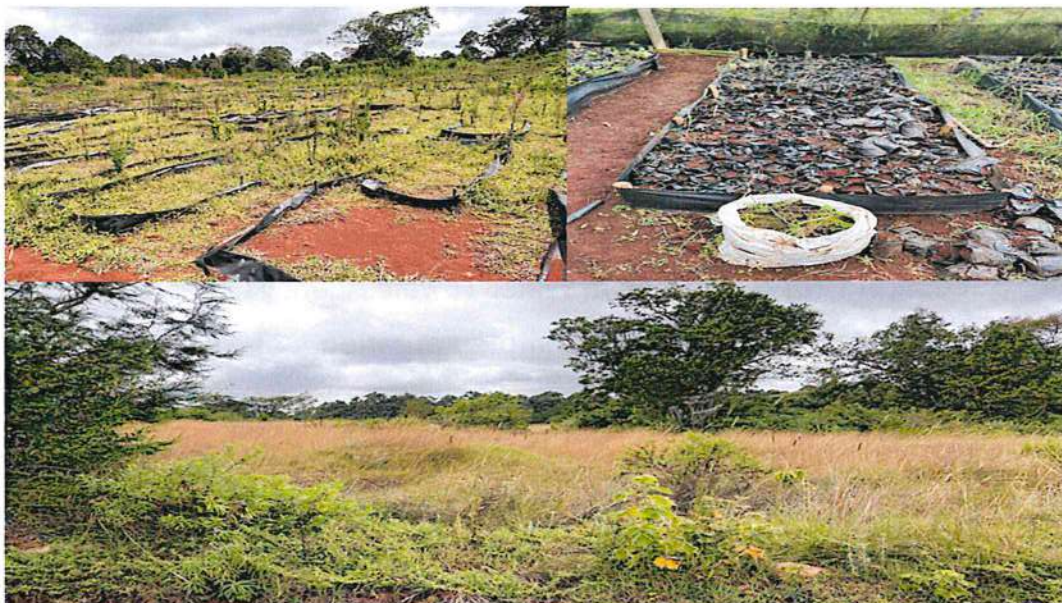
Picture 4: The Status of the National Bamboo Demonstration Centre

4.56 The audit revealed that the Agency spent approximately Ksh.147.7million during the period 2017/2018 to 2021/2022 towards establishment of bamboo enterprise. This involved establishment of a National Bamboo Growing Demonstration Centre at Kaptagat Forest, Elgeyo Hills, among other activities. The site was to act as a bamboo demonstration centre where interested individuals would learn about the commercial value of bamboo and also procure bamboo seedlings. However, physical verification revealed that the site had been neglected as shown in **Picture 4**. Therefore, the intended objective of providing an alternative livelihood through bamboo commercialization was not achieved.

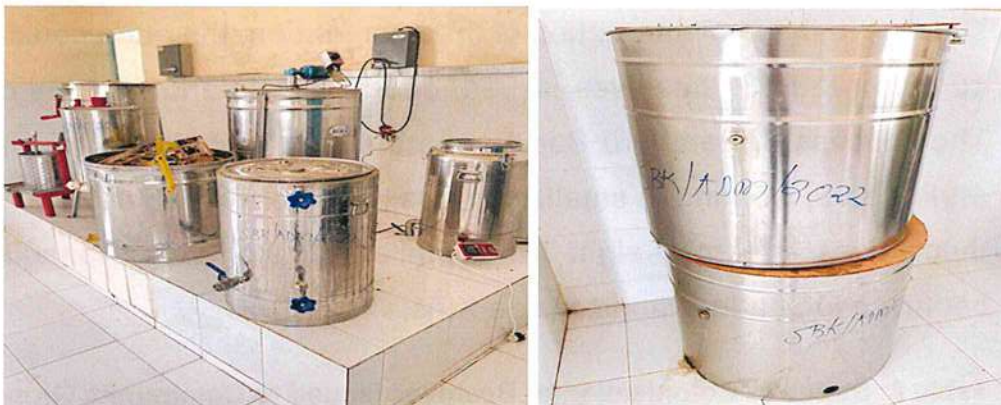
Picture 5: Samburu Bee Keepers Honey Processing Factory

- 4.60 The audit revealed that out of the eight (8) groups verified, only Samburu Bee Keepers had set up a honey processing factory as shown in **Picture 5**. However, interactions with group officials revealed the Agency provided a manual centrifuge, yet the honey produced in the region was highly viscous, requiring heating during processing. Consequently, the group did not use the equipment and resorted to use the equipment supplied to them later by the World Vision.

Left photo- Honey processing factory setup; Right photo- manual centrifuges

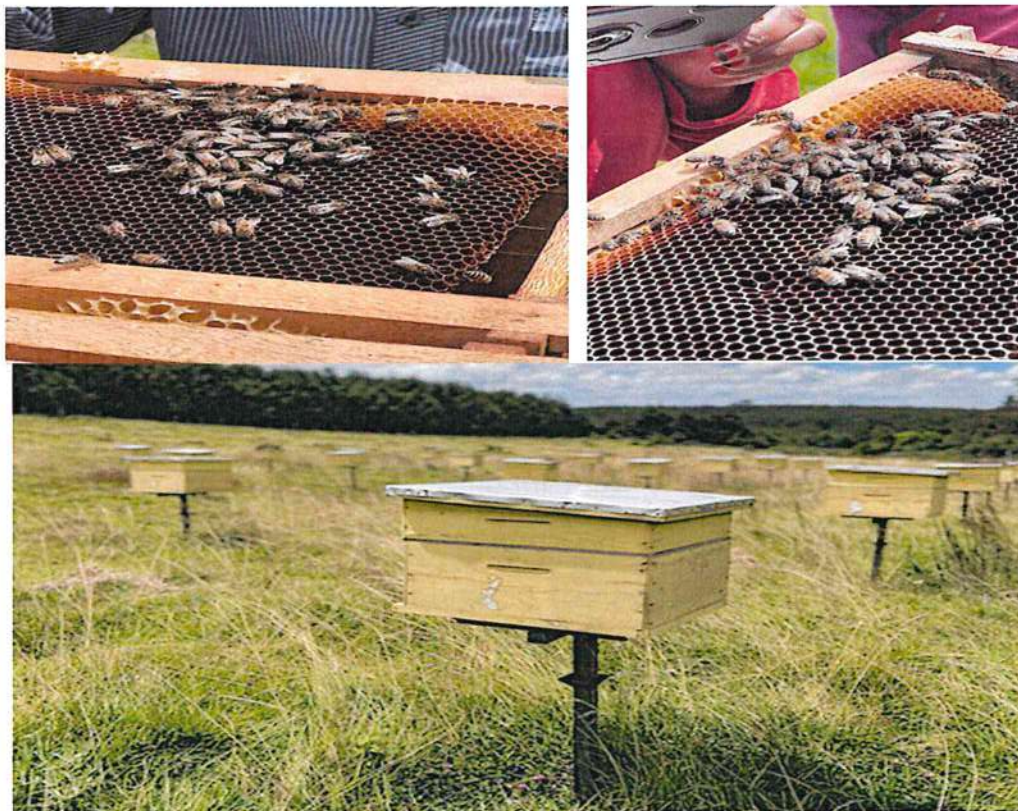
Picture 6: Status of Beehives in Kiptunga Forest Apiary

- 4.61 Some of the challenges affecting colonisation included pest infestation. In addition, physical verifications revealed that beneficiary groups lacked skills on apiary management and location of the apiaries. For example, physical verifications revealed that the beehives issued to a community group in Kiptunga Forest were initially colonised but got infested by insects. It was observed that although the beehive stands had provision for putting oil to deter insects, the group had not placed oil on the stands. The group had also located its apiary in an open area. Besides, the apiary had overgrown grass through which insects could easily access the beehives. Status of beehives in Kiptunga Forest were as shown in **Picture 6**
