# Report of the Auditor General on the

## Management of Environmental Degradation Caused by Mining Activities in Zambia.

July 2014

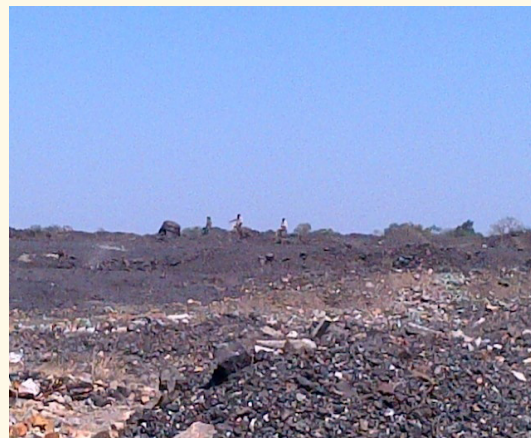
MCM slag dump No.1, L.C.M – old and new slag dumps, KCM unlicensed slag dump and dump No 67, Nkana slag dump-Chambishi Metals Mine had unrestricted access.

*Illegal miners on old slag dump at LCM*

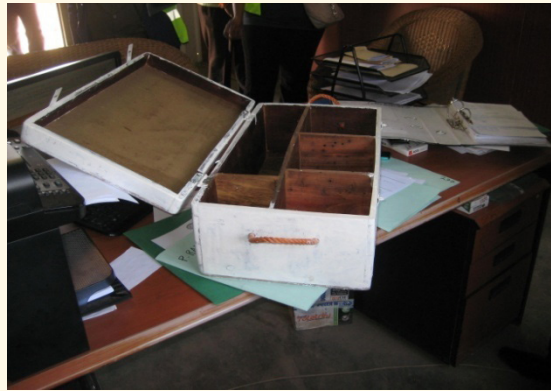
All the mining facilities visited with the exception of Luanshya Copper Mine Plc, had fire fighting equipment. It was also observed that KCM- Nchanga, Lumwana Mining Co, Chambishi Copper Smelter and Chibuluma Mine had no first aid kits on site contrary to the provisions of regulations. It was further observed that Maamba Collieries Plc. had an empty first aid box. See picture below.

*Empty first aid kit-Maamba Collieries Plc*
