# Environmental Audit report on Water Pollution of the Kelani River

Report Number : PER/B/ENV/2018/01

**National Audit Office**

**Environmental Audit Division**

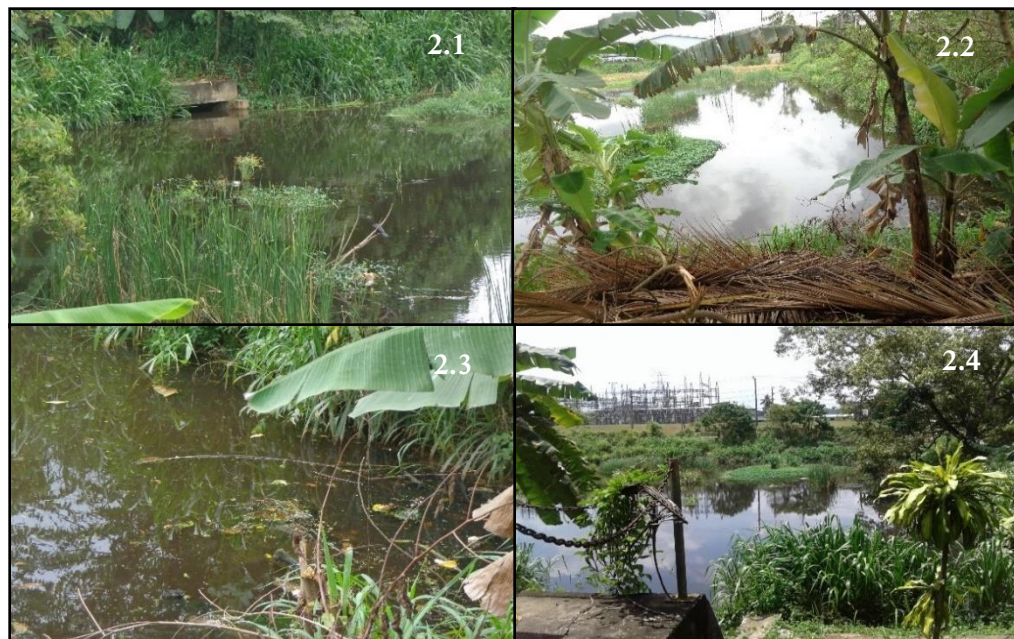
**Picture No. 02**

- IV. In certain occasions, the generation of waste water in the inhouse treatment plants exist in certain industries established in the waste water purification Centre generate waste water was increased more than the existing plant capacity that actually generates waste water. However, in comparison with this increase, the capacity of the inhouse treatment plants available in factories has not been increased and the capacity of the common waste water treatment plant has not been increased simultaneously and as such unpurified water and not purified water up to the specific standards was discharged to the retention pond through the common treatment center.

- d) Quality of the water in the retention pond located in this zone cannot be satisfied. It was observed that at the end, its water mixed up with Kelani river through the Yaha oya. Observations in this regard appear below.

- I. The physical verification observed that the capacity to be purified by the common waste water treatment unit is exceeded now and the excess water is not properly purified when the capacity of waste water, generated by factories is exceeded the capacity of inhouse treatment plant, and there is a risk of mixing the waste water with the retention pond by over following the equalization tank in rainy days.

- II. According to the letter No. M/SEPZ/W 01 dated 26 June 2018 of the operations and maintenance Manager of the National Water Supply and Damage Board, it was stated that the surplus waste water, without doing any treatment, was disposal of directly to the retention pond (Annexe – 17)

- III. Action has not been taken in accordance with sections 23 (G) and section 23 (N) (I) of part IV (B) of the Environmental Act and it was observed that in rainy season, this waste water washes and adds to the Kelani River through canals and as a result, the river water is polluted (Annexe - 01).

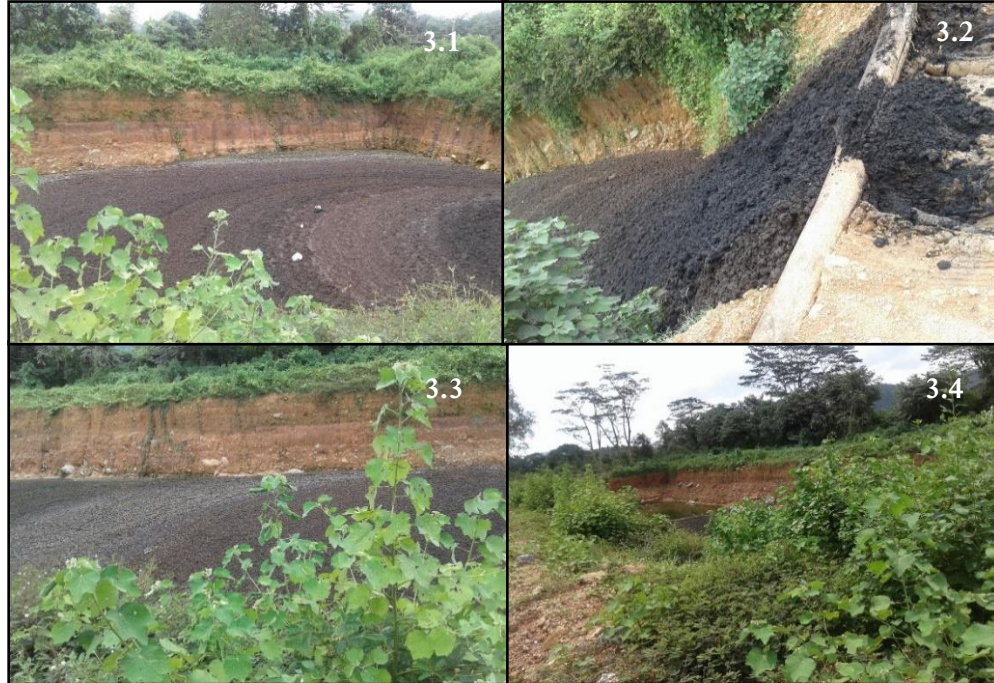
**Picture No. 03**

- e) Waste water generated from the production process of 15 factories situated in the Seethawaka export processing zone is subject to purification process at the common waste water treatment plant after being purified by the in houses treatment plants located within the factories and the remaining sludge is deposited in a place, 65 meters in length, 20 meters in width and 4.5 meters in height put up by laying a clay layer to the bottom. It was revealed that about 15 tractor loads of sludge are disposed of daily to this place (Annexe - 19).

**Disposal of sludge of the Seethawaka export processing zone**

As a security coverage is not in existence in a manner covering the soil layer round the wall from the bottom to the top of the open sump put up now for the disposal of sludge through the common waste water treatment system when the sump fills up with sludge, rain water is mixed up and absorbed waste into the earth, resulting a risk of water sources being polluted. The physical verification observed that this waste improperly was disposed of to an elevated open yard within the export processing zone before and there is a possibility that water sources may be polluted by mixing that waste with rain water as well.

- VIII. Establish a formal methodology to dispose of sludge safely in the export processing zones (3.4.1. (e))
- IX. Establish a methodology to separate and dispose of hazardous and innocuous solid waste safely in every industry and do follow – up action by the BOI (3.4.1 (f))

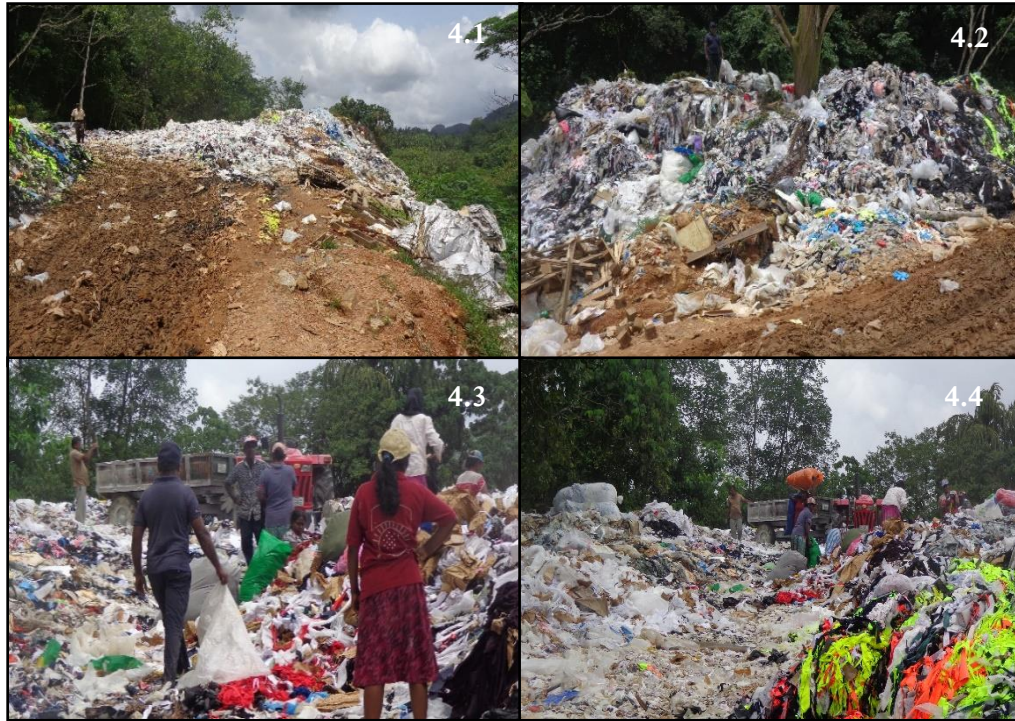
**Picture No. 04**

- f) Solid waste generates within the zone improperly disposed of to the open land situated within the investment zone. A lot of solid waste, consists of textile pieces, Yoghurt cups, rubber pieces polythine and other solid waste had been improperly disposal of to this land.

**Solid waste disposal yard in the Seethawaka export processing zone**

Accordingly, all hazardous and innocuous solid waste is discharged to an open land without being classified and as a result, it was observed that this waste is mixed up with rain water in rainy days and adds up to the Kelani River causing adverse effect on the quality of water.

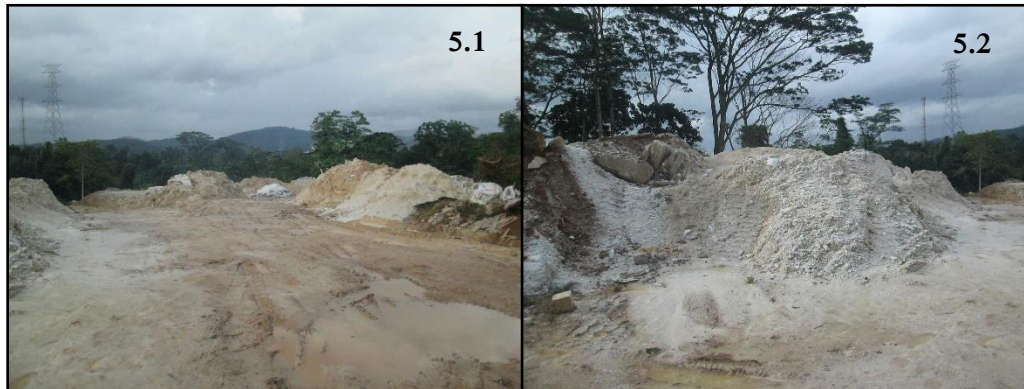
**Picture No. 05**

Waste generates in the production process of a private factory was stacked in an open place near the Kelani River.

**The manner a private factory has stacked waste generates of its production process.**

- I. The physical verification carried out in audit observed in this connections that waste generates in the production process of this factory has been stacked in an open place near the Kelani river. Especially in rainy season it was observed that this waste may flow down to the Kelani river being mixed up with rain water.

- II. In terms of the letter No. M/SEPZ/W – 08 dated 31 May 2018 of the National Water Supply and Damage Board, it was stated that as the waste is discharged improperly as stated above, the limit of electric conductivity of the water intake where water is obtained for the requirement of the Seethawaka zone is now at the limit of 105  $\mu\text{s}/\text{cm}$  although it needs to be existed at 60  $\mu\text{s}/\text{cm}$  limit. It is therefore observed that the standard parameters were exceeded by 45  $\mu\text{s}/\text{cm}$ .

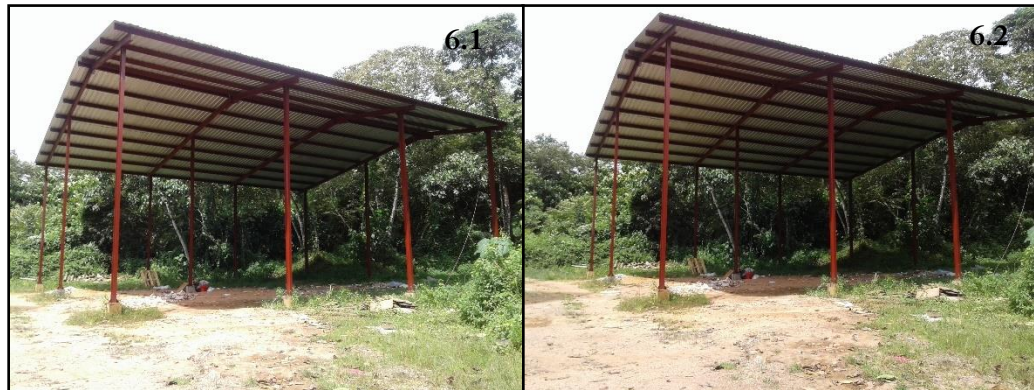
**Picture No. 06**

- Even though this centre was put up it was observed that it has not been utilized for the above purpose even up to the date of audit on 13 July 2018.

**Solid waste separation center of the Seethawaka export processing zone.**

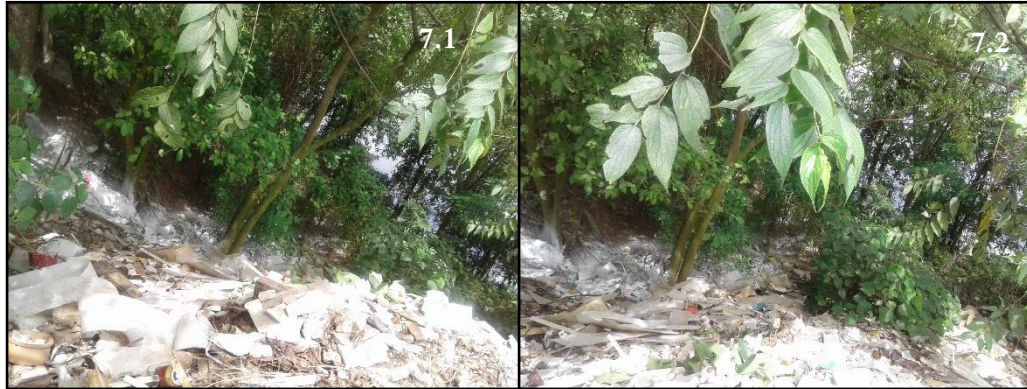
**Picture No. 07**

- a) Waste water purifies in the Biyagama export processing zone, is issued to a retention pond situated near the Waste Water centre. Finally, the normal process is that this water flows through the retention ponds and foregatheres to the Kelani River through the "Menikagara" canal. Accordingly solid waste of one factory situated in the Biyagama zone subjected to audit disposed of improperly to a place near the retention pond. It was therefore observed that there was a possibility of adding pollutants to the purified water directly and finally it badly effects water of the Kelani River.

**Solid waste disposed of by a factory in the Biyagama export processing zone.**

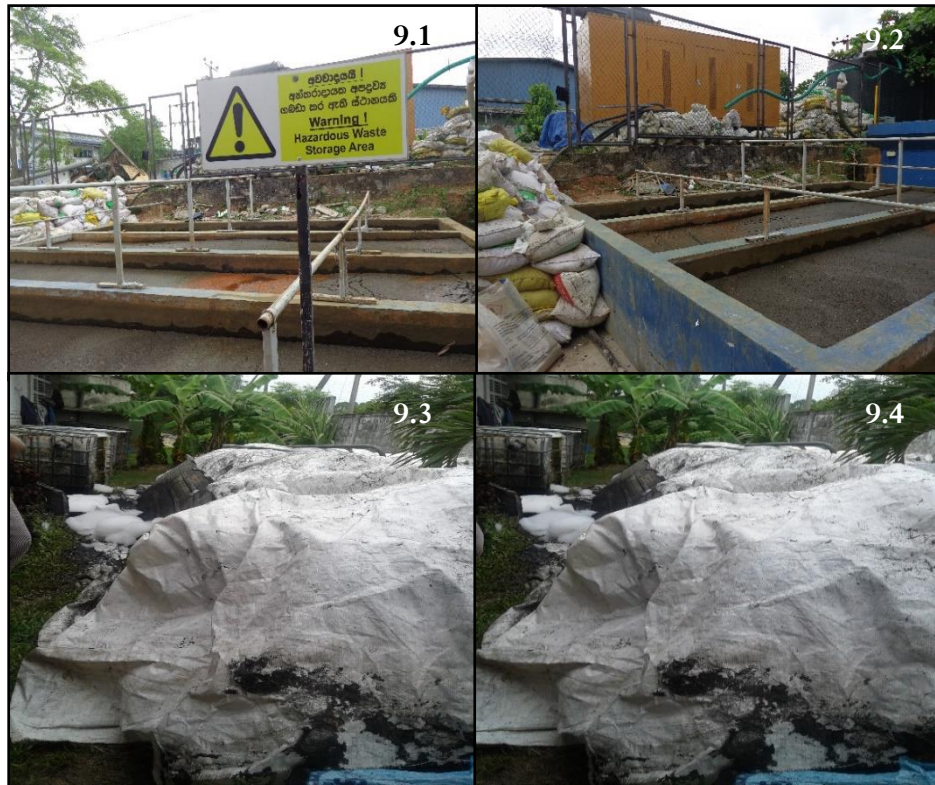
Picture No. 09

**The manner how the sludge generates from a factory in the Biyagama export processing zone is deposited in an open yard**

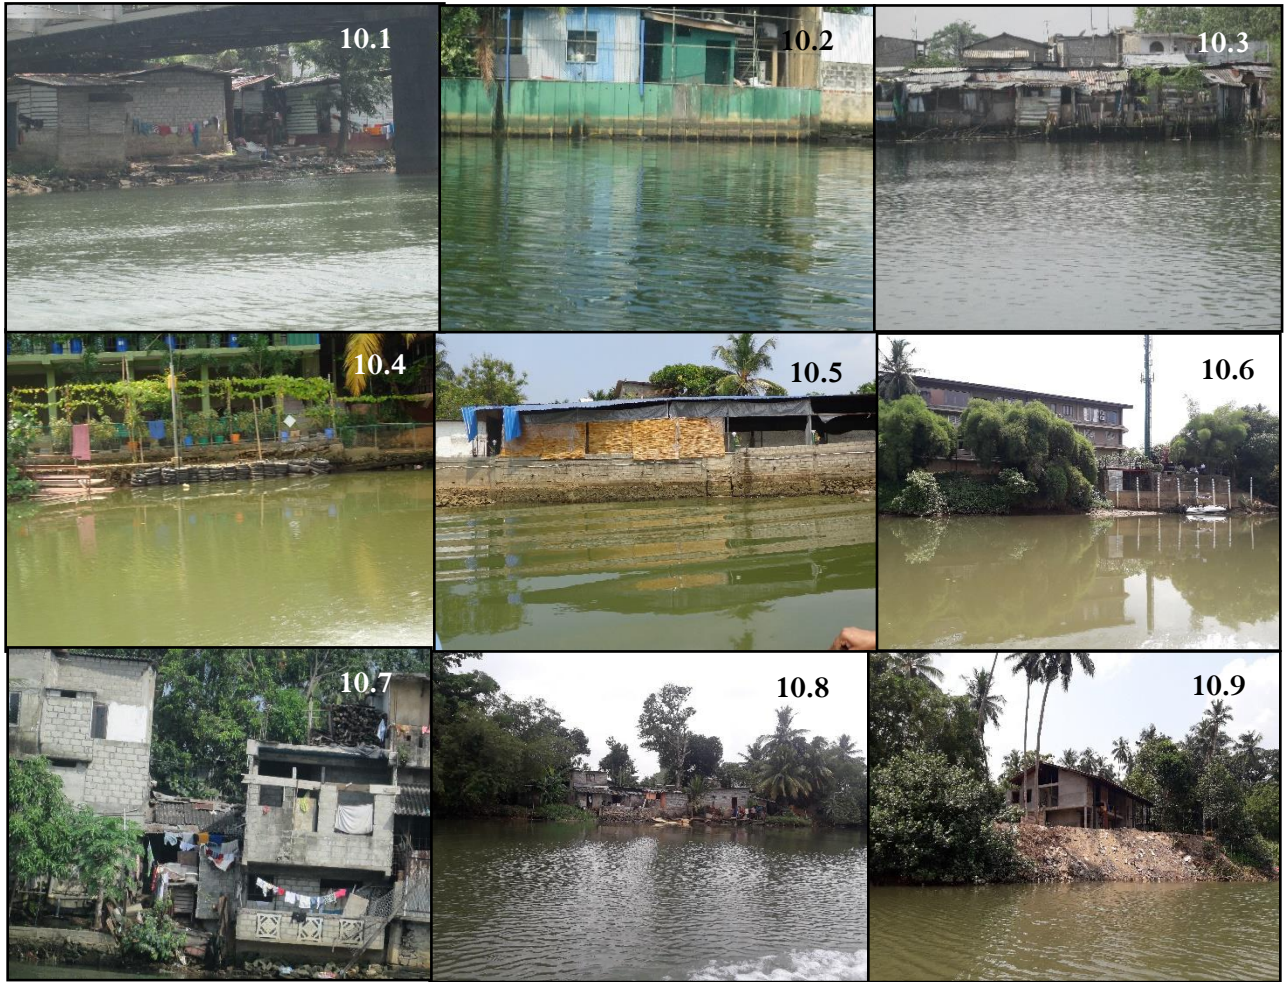
**Picture No. 10**

- a) In terms of paragraph 2.5 of the circular No. 8/2014 dated 01 December 2014 of the Department of Irrigation, a construction is to be done after the allocation of 198 meters away from the river bank and in places more than the width of 15 meters of the river. In contrary to that, audit observed uncouthable number of permanent and temporary constructions, exist near the river bank and a few photographs obtained from various places are presented below (Annexe - 11)

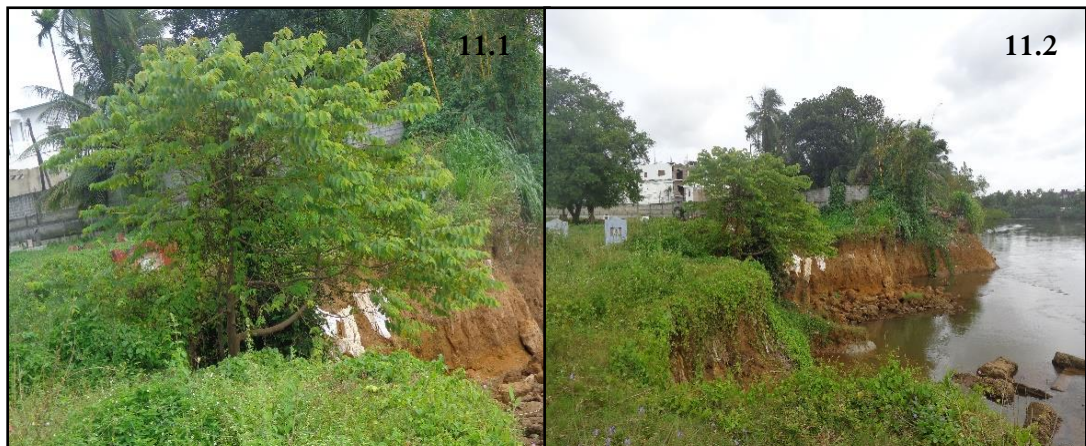
**Picture No. 11**

**b)** The wall of the Kohilawatte cemetery situated in the South bank of the down river was collapsed towards the river. A risk of gathering dead bodies and polythene coverage to the river was observed.

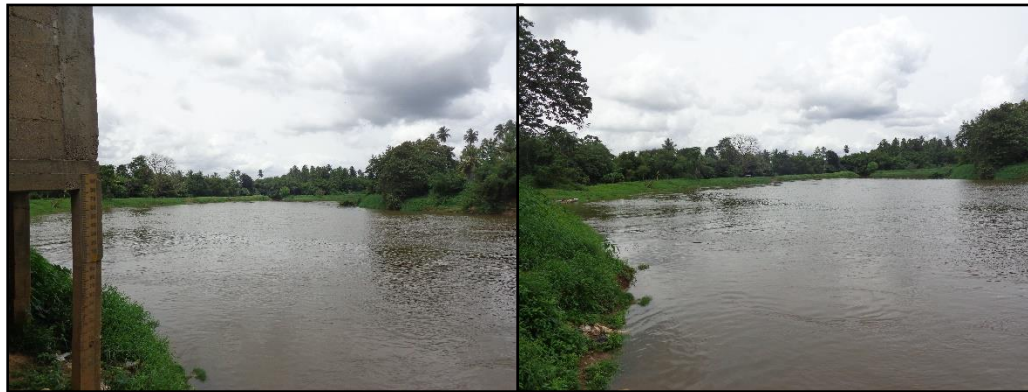
**Picture No. 12**

- c) In flowing the Raggahawatta canal exists in the left bank of the middle of the river up to the mouth of the Kelani River, it had become dirty condition due to disposal of pollutants by construction works done both sides of the river and the encroachment both sides have disrupted in flowing the canal.
- d) A lot of buildings were constructed in the river bank near the two turning points with the letter “Z” shape at Rakshagala area situated in the south bank of upper river and it was observed that this affects the river pollution.

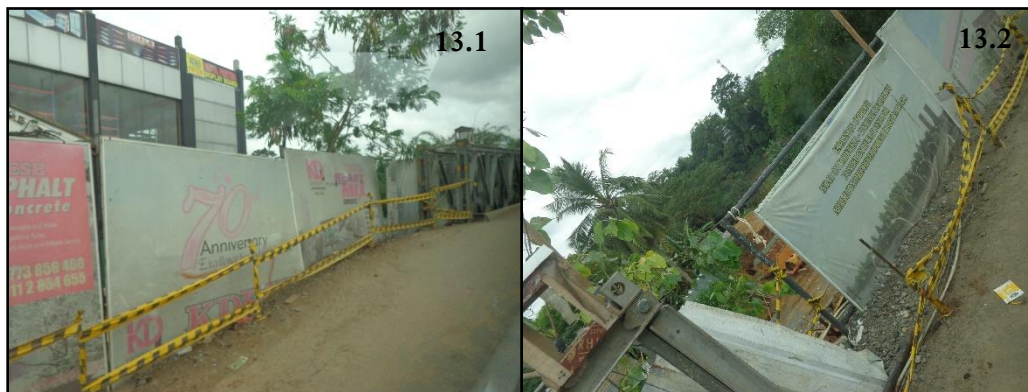
**Picture No. 13**

- e) It was observed that constructions of grand scale businesses are in progress on the river bank near the kaduwela Bridge causing a lot of damages to the river bank.

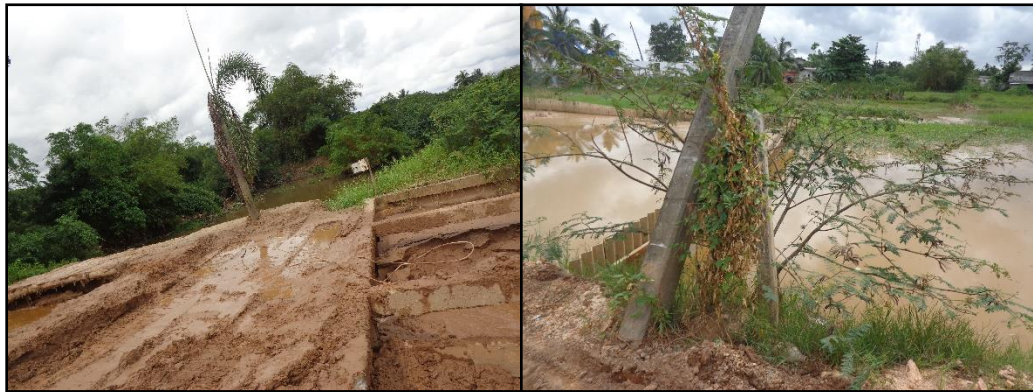
**Picture No. 14**

- f) A large scale earth washing locate recognized as an industry with very high Environmental risk belongs to “A” grade, according to the classification of the Central Environmental Authority, is situated near the Hettige canal flows down near the wele junction. Adding up waste to the Hettige canal flows near that industry could be seen from this industry and also observed that lands near the Hettige canal are reclaimed.

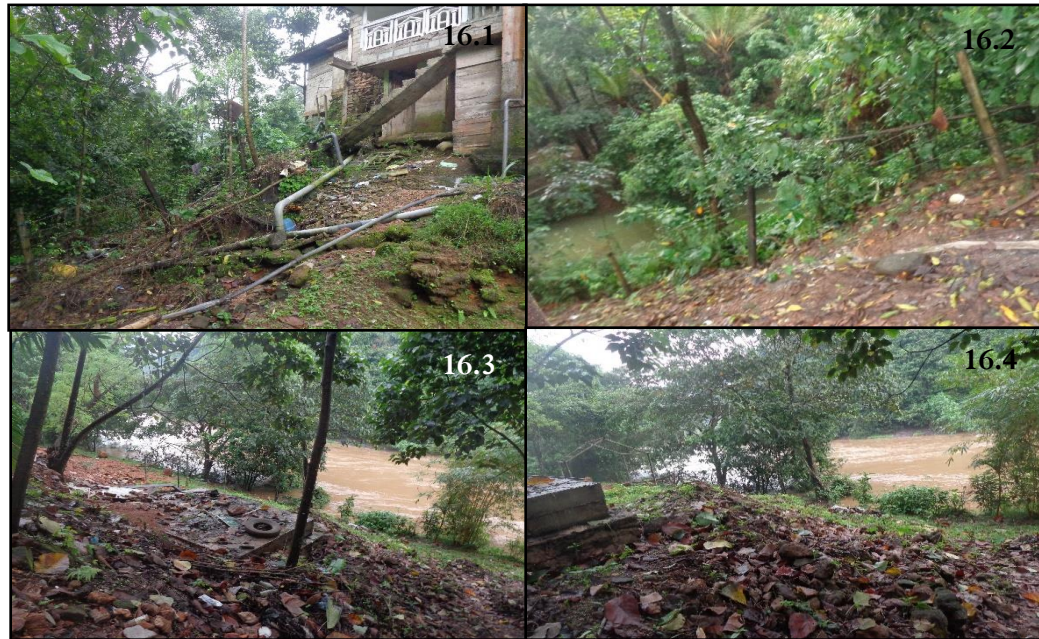
**Picture No. 16**

h) Even though a period of 18 years elapsed since the opening of a hotel near the river at Kithulgala area, the environmental protection license had not been obtained. It was observed that sewage and other solid waste of the hotel is mixed up with river water through the canal. Furthermore, even though septic tanks were built within the river limit, they were not subjected to check to ensure the correctness of their operations by responsible parties.

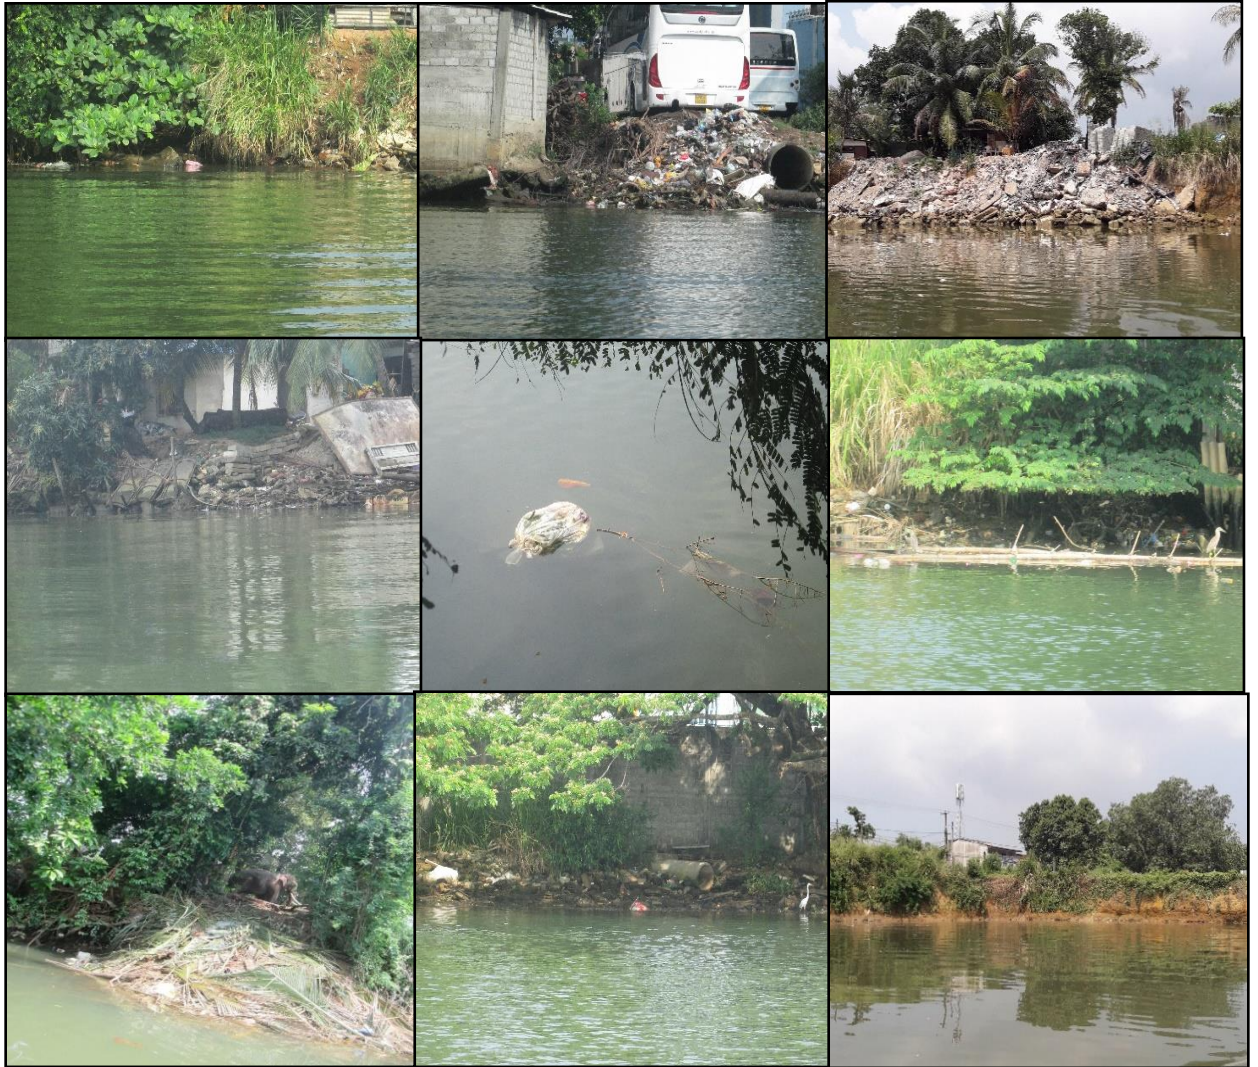
**Picture No. 17**

a) In this observation tour, disposal of solid waste to the river in a massive scale in the areas of Modara, Mattakkuliya, Wellampitiya, Peliyagoda, Kolonnawa and Angoda can be seen. Plastic, empty bottles, polythene, papers and all demolished parts of buildings have been disposed of to the river. It was further observed at the river bank tour that all rubbish discharged by encroached houses at Mattakkuliya, Modara, Wattala, Wellampitiya, Peliyagoda and Grandpass areas is accumulated to the river water as depicted in the following pictures.

- VIII. Prevent improper disposal of solid waste and make aware of the general public continuously about the locations of the river subject to be polluted (3.5.2)

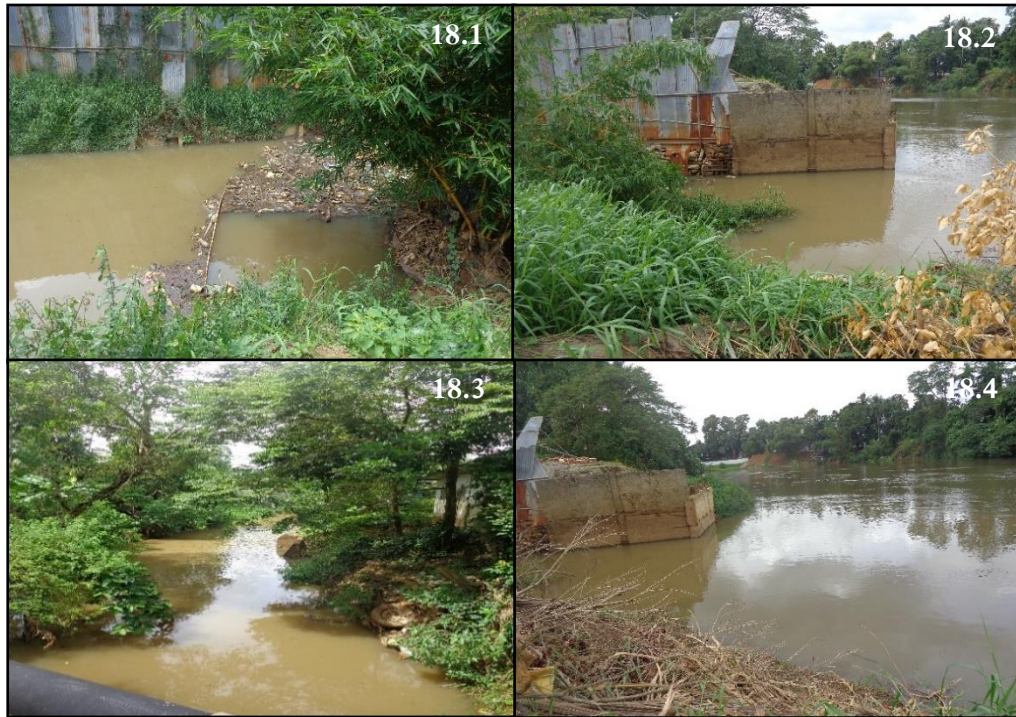
**Picture No. 18**

**b)** It was observed that purified waste water disposed of by factories in Biyagama export processing zone adds up to the Kelani River through the Rakghawatte canal.

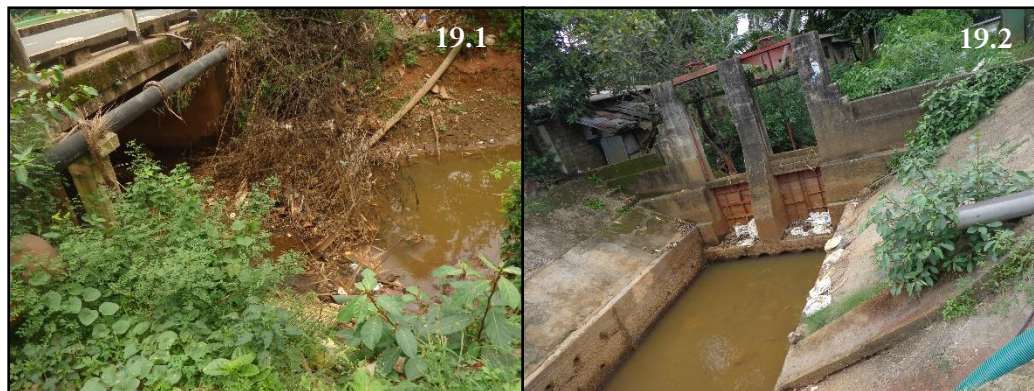
**Picture No. 19**

c) The pattiwila canal beings and flows near the Ceylon Petroleum Corporation and factories and houses are built both sides of the canal. It was observed that all pollutants disposed of by those factories flow down through this canal. Water in this canal has become discolored and impured as observed at several audit visits. Similarly, it was observed that this canal joints with the Kelani river in a place nearest to the intake which supplies water to the Pattivila water purifier.

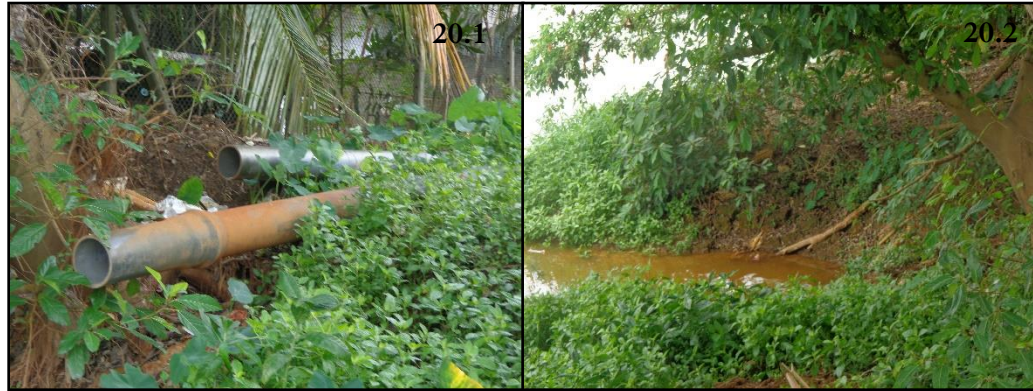
**Picture No. 20**

- d) Even though action has been taken to remove impured water by using 3 main pipe lines along with the highway near the Pattiwila pump house, this water again dischrages to the Kelani River down and near the pump house.

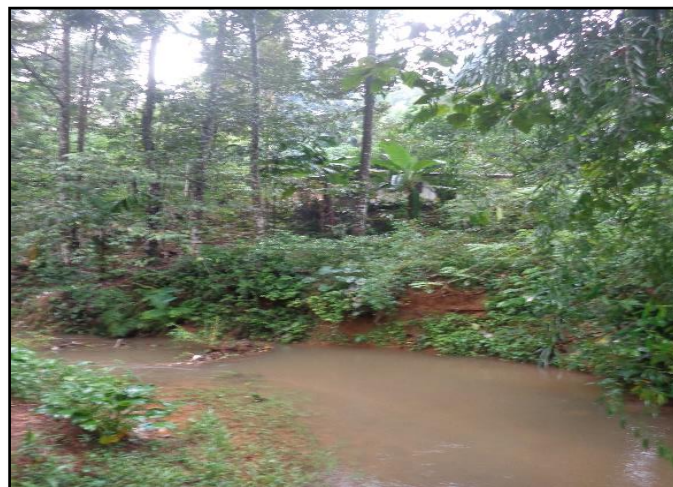
**Picture No. 21**

- e) It was observed that toilet impurities used and removed by the families live near the Batakiththa canal and tourist hotels constructed in Yatiyantota and Kithulgala areas add up to the Kelani River.

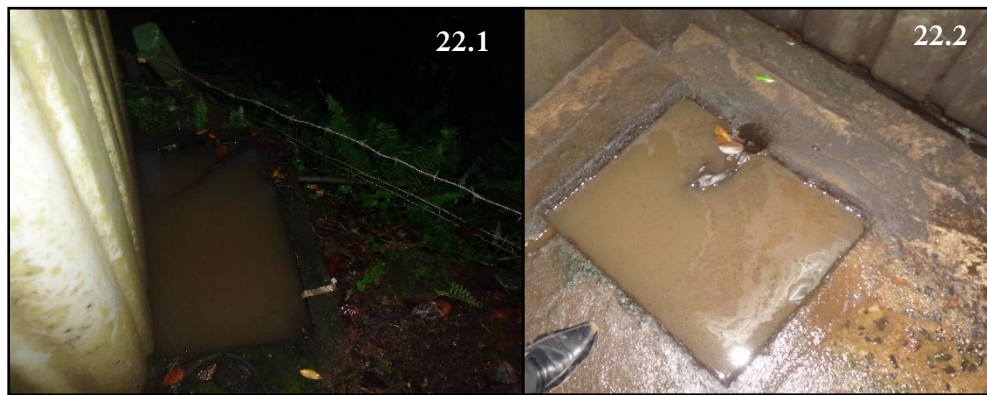
**Picture No. 22**

f) It was observed that waste water of a vehicle service station operates near the Kithulgala area and associated with the river and the waste water of 07 vehicles service stations operated in the areas from Kaduwela to Kaluaggala released to the Kelani River without being purified. It was further observed that as the water uses for washing the body of vehicles in most service stations is not purified as per standards and sludge is not disposed of with eco – friendly and it directly effects the water pollution of the Kelani River. Attention in this regard was not paid by the responsible entities.

**Release of waste water accumulated in a service stations to the river without being purified.**

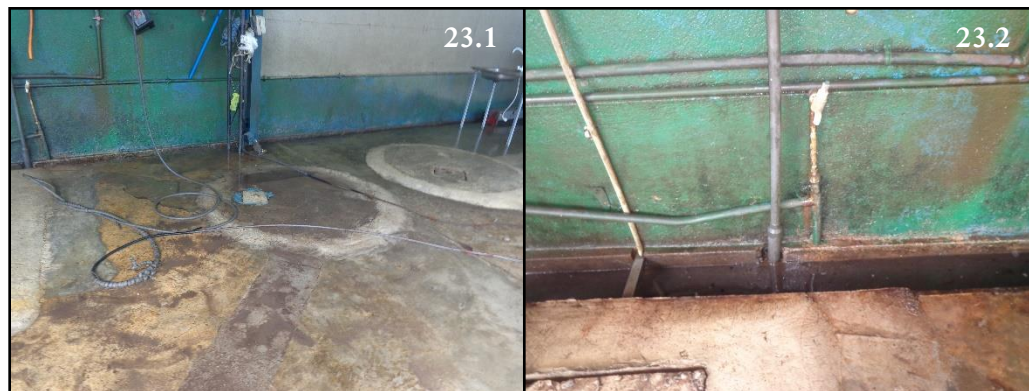
**Picture No. 23**

**Disposal of water uses for washing vehicles bodies without being purified.**

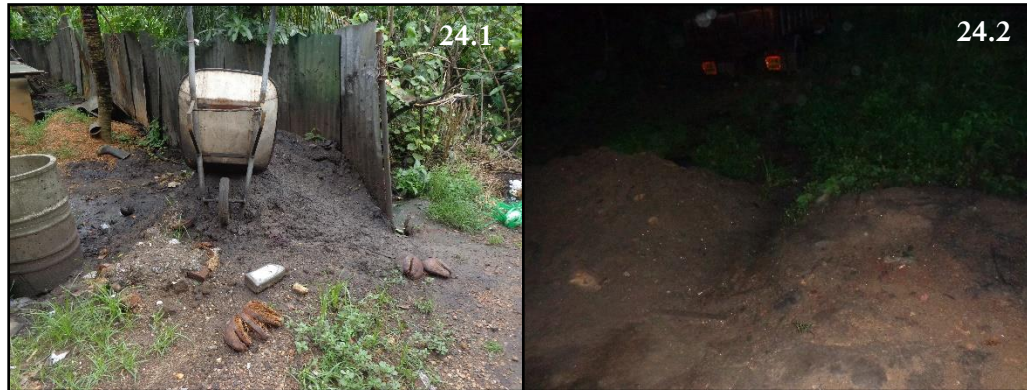
**Picture No. 24**

**Sludge discharged unproductively in an open yard**

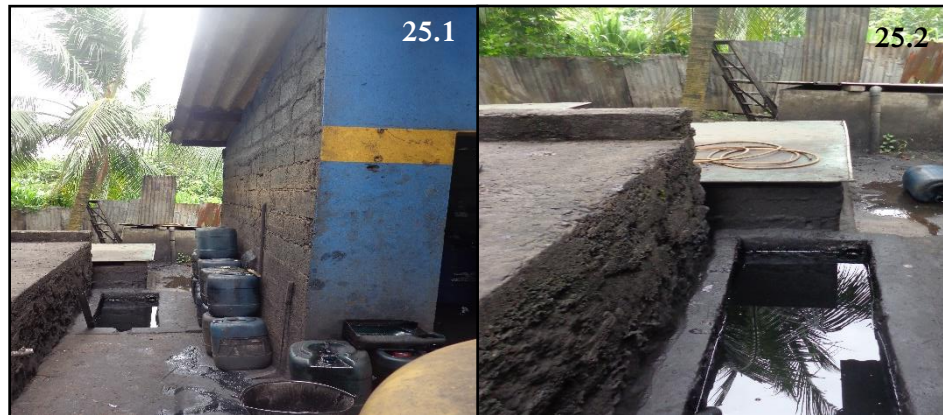
**Picture No. 25**

**The manner constructed the waste water collection locate of a service station in an open yard.**

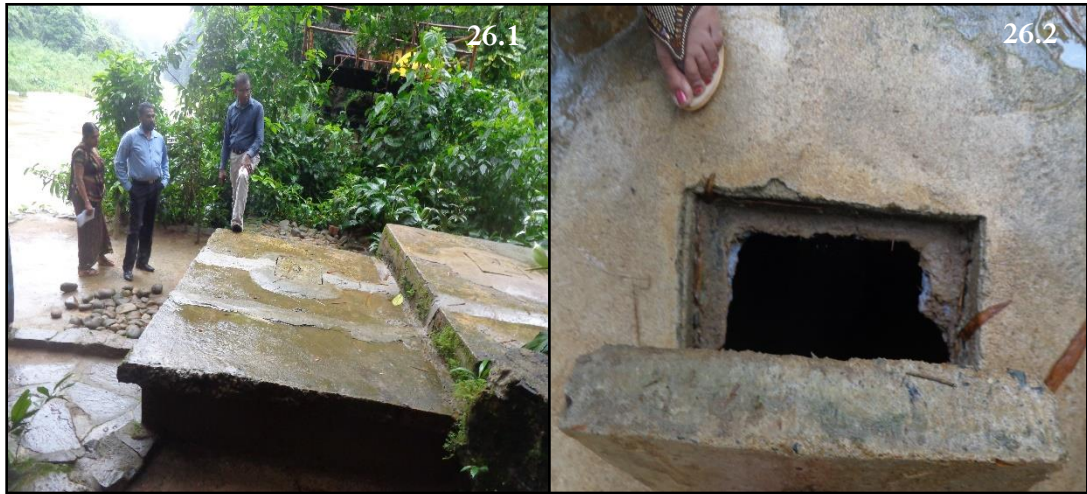
**Picture No. 26**

- g)** Toilets of a famous hotel situated in Kithulgala area, associated with the river are constructed very close to the river and it appeared that there was a leak in the waste water soakage tank. This soakage tank is situated very close to the Kelani River as well as the kitchen with a severe smell. Even though the officers of the Provincial Environmental Authority instructed not to use those toilets, it was observed even up to the date of audit that they were being using.

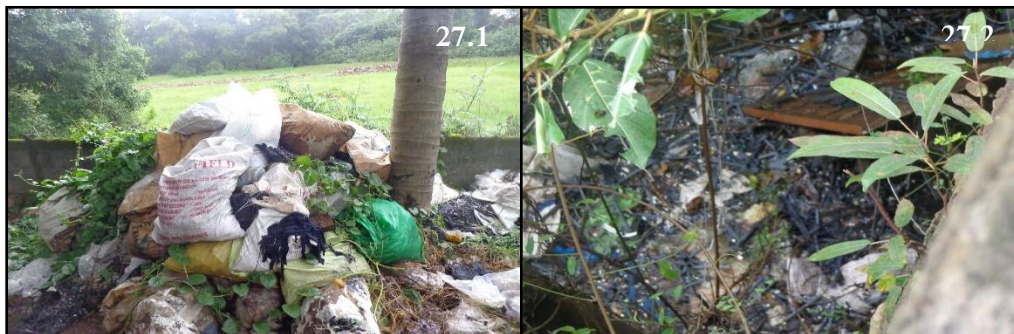
**Picture No. 27**

- h) Remaining waste in the production process and production scraps of the plastic manufacturing factory situated near the pattivila canal have been Discharged improperly to the factory premises and the pattiwila paddy field.

This waste improperly disposed may add up to the Pattiwila canal and the water so impaired joints with the Kelani river through the Pattiwila canal. As the Pattiwila pump house is located nearby, it was observed that this may effect the water obtains for purification.

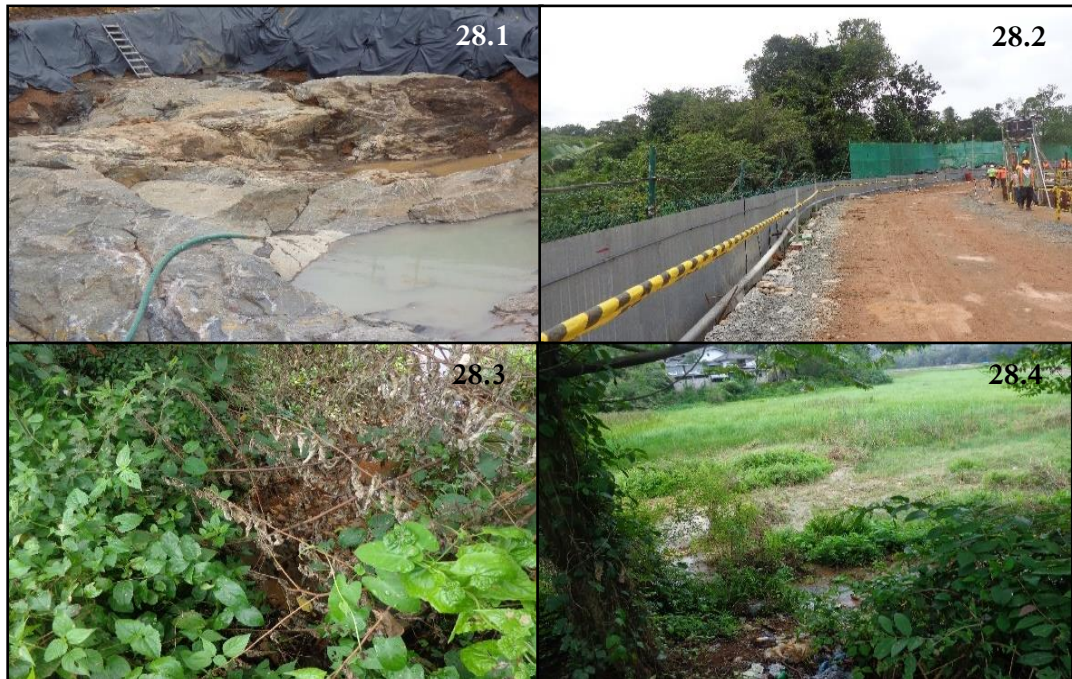
**Picture No. 28**

- i) In the affairs of the phase II of the Kelani River south bank water scheme, a chemical contains calcium oxide, cement chemical, gypsum and hecsavelent chromium mixes up with water is used for the pulverization of a huge rock and this water, contains with chemicals is emitted to the Pattiwila paddy field by pipe lines without being properly purified. In rainy season, it was observed that there may be room for adding up these chemicals mixed up with water to the Kelani River via Pattiwila chanal.

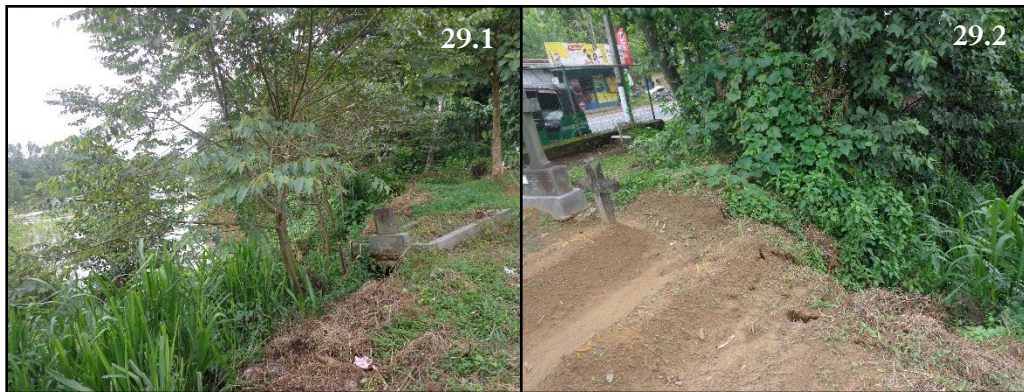
**Picture No. 29**

- j) The borders of the cemetery situated in the boundary of the Kelani River at Hanwella area in the mid left bank of the river was washed and as such, it was observed that there is a risk of adding up waste in to the Kelani River.

**Hanwella cemetery**

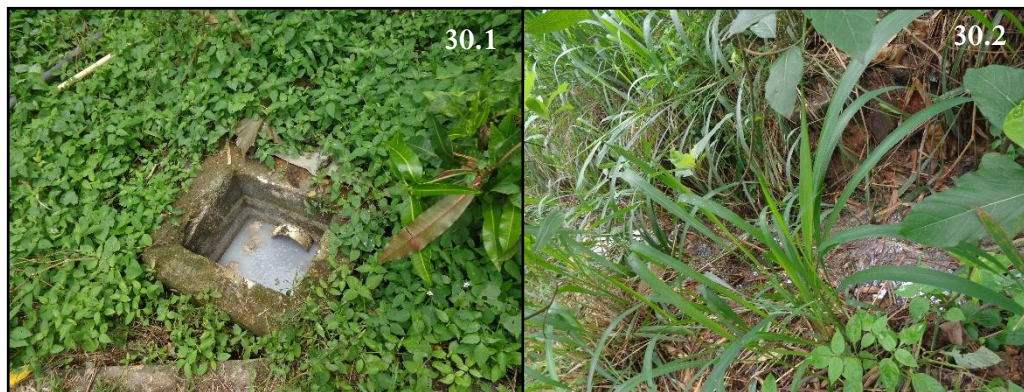
**Picture No. 30**

- k) It was observed that waste water disposes by a yoghurt factory in Kaduwela Town is directly discharged to the Kelani River, without being purified.

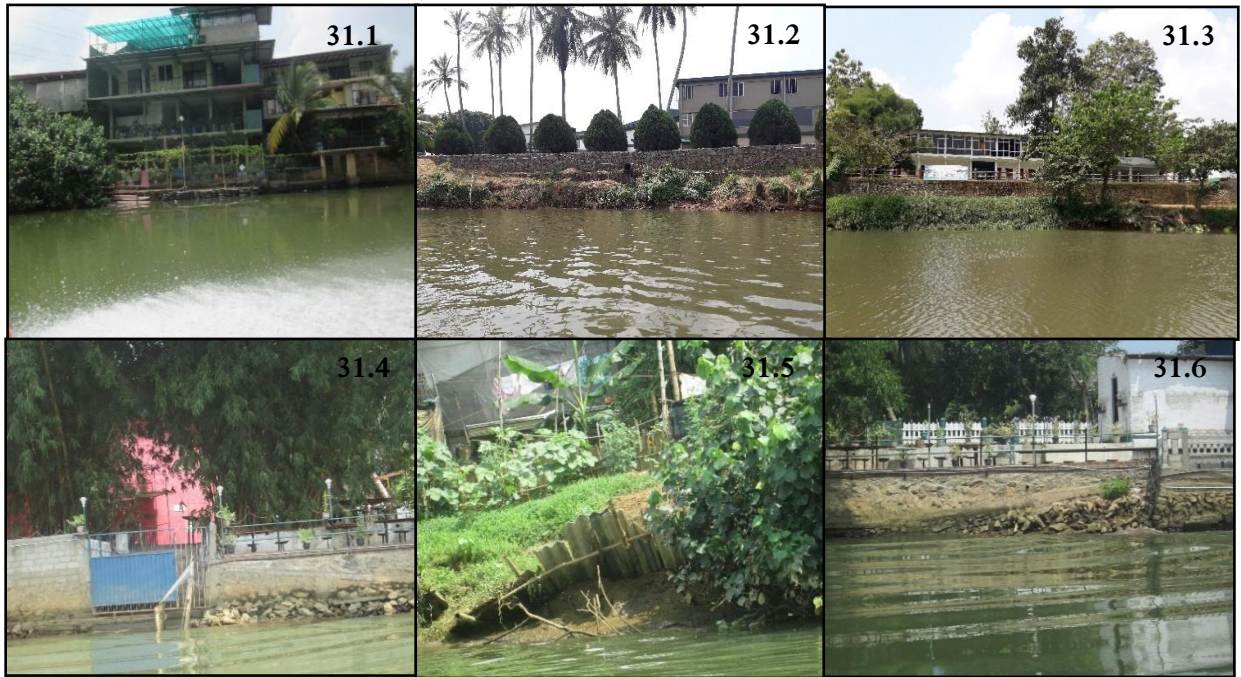
**Picture No. 31**

- a) Construction of hotels, factories and other constructions or cultivations existed in the locates of river boundary with aesthetic attraction was observed. of them, it was observed that space is not separated in the constructions of peliyagoda and Angoda areas for river reservation.

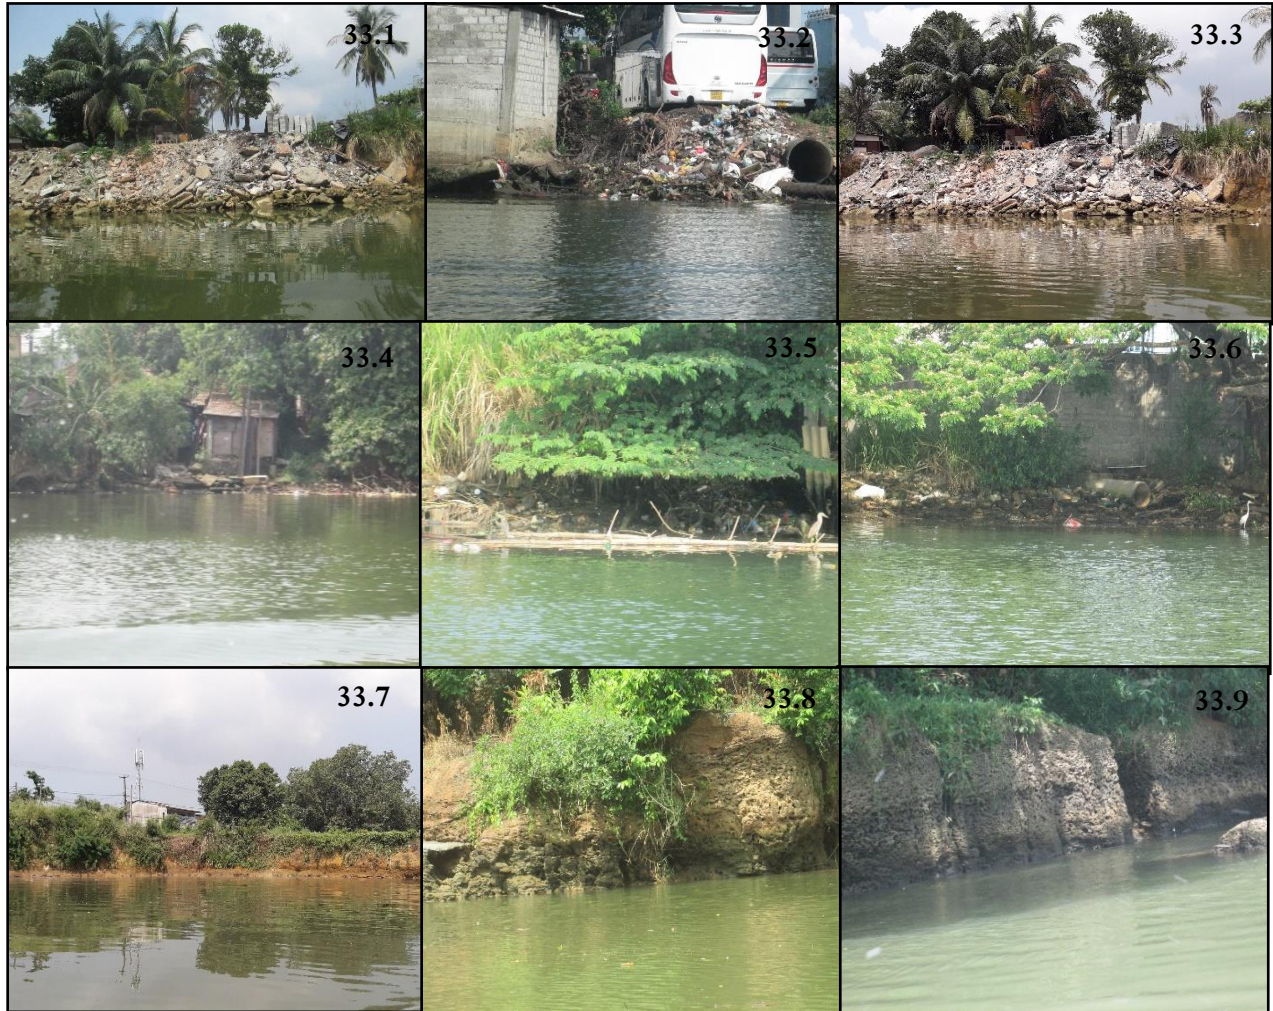
Picture No. 33

- a) Ample environmental destruction in the areas from Modara to Ambathale can be seen and it was observed that unsympathetic actions of the main himself cause this environmental destruction. Disposal of garbage without proper management, washing out the river bank, unauthorized constructions in the river boarder and disposal of sewage effected this environmental destruction. Pictures taken in this regard appear below.

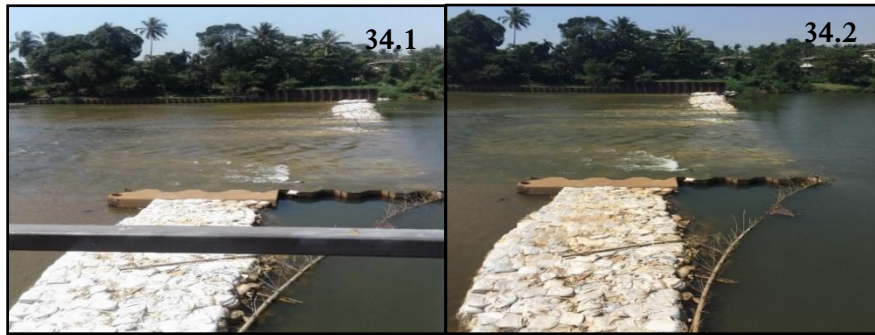
Picture No. 34

b) Even though it was observed that temporary precautions have been taken to prevent mixing of sea water near the Ambathale pump house to the Kelani River which is the main drinking water source of western province, the requirement of paying further attention in this regard is also observed.

The manner sand – bags is spread for the prevention of mixing saliferous sea water with drinking water at the locate where water is obtained for the Ambathale pump house.
