AUDITOR
GENERAL'S
OFFICE

KEY FINDINGS OF PERFORMANCE AUDIT ON FUVAHMULAH CITY WATER AND SANITATION PROJECT

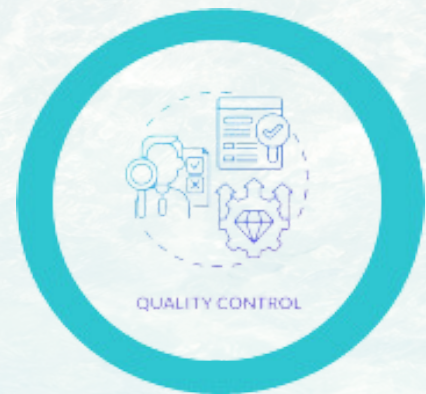
All the quality control measures planned for the Fuvahmulah Water and Sewerage Project was not executed out during the design and implementation phases. This resulted in some project works being inspected and approved by experts who were not approved by the Client (Ministry of Environment Climate Change and Technology). Furthermore, certain works were not inspected or approved at all.

Additionally, a conditional approval was provided by the regulator for the Detailed Design Report of the project, stating that it should include necessary amendments and additional information. However, it was not ensured whether these changes were made and incorporated into the design report.

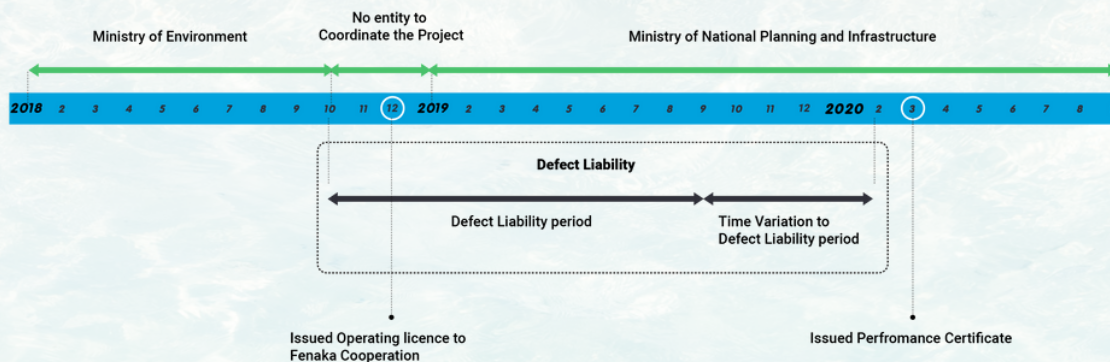
Projects like this require close coordination and monitoring. However, for a period of four months, no institution was coordinating the work of the project. This includes three months of the Defect Liability Period, which is the time to identify and resolve any issues with the water supply and sewerage system established by the project. During this three-month period, there was no agency to coordinate the project and address any issues that were identified and reported by the Supervision Consultant and the monitoring and evaluation of the project were not carried out effectively due to the lack of coordination.

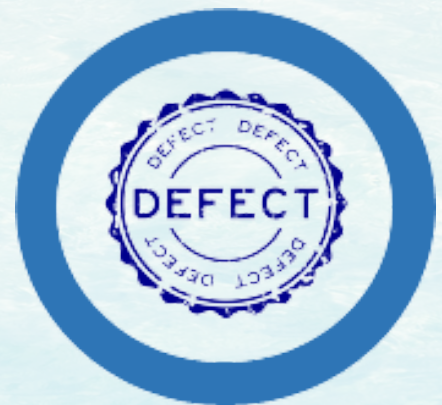
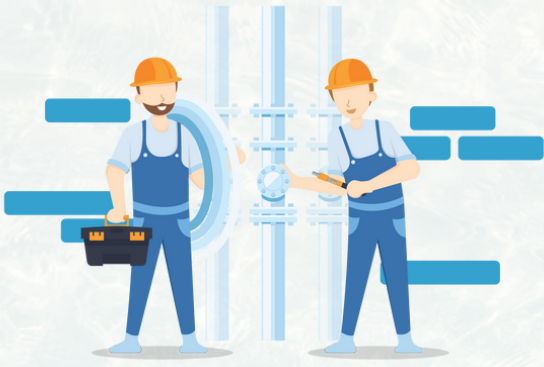
Additionally, during the Defect Liability Period, both the contractor and the Operator were obliged for operating the system. This resulted in hindering the opportunity for the Operator to operate and identify the issues in the system during the Defect Liability Period. Although the operator themselves have not done enough to overcome this challenge and continue with the operations of the system, there were no regulatory actions taken against them. The Ministry of Planning and Infrastructure also issued performance certificate to the contractor without fully resolving the issues identified during the Defect Liability Period, stating that the project was completed.

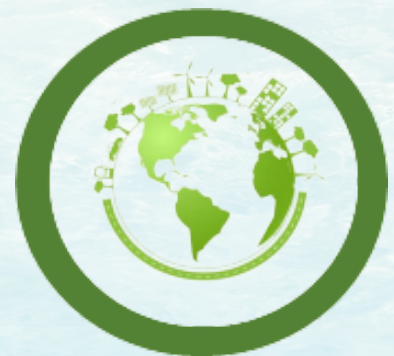
Process of Manually Carrying Raw Sewage

Although projects conducted by the Government should follow the principles of sustainable development (economic, social, and environmental), the actual cost of the project has exceeded the initial anticipated amount. This includes the costs of temporary solutions brought after the project's completion to cater for the overflow of sewerage effluents unto the island. As a such, the service provider assigned the task of manually collecting and disposing of sewer from manholes and vacuum chambers to private parties without going through the bidding process. Furthermore, the total cost for this work was not fixed and instead charged for each manhole cleared and the rate at which this work was awarded was higher compared to previous rates. Over a period of 21 months, a total of MVR 8,673,370 was spent on collecting the sewer from manholes and transporting in to the Sewerage Treatment Plant on tanks mounted in pickups. The procurement process during this phase been deemed to be not in the best interest of the state.

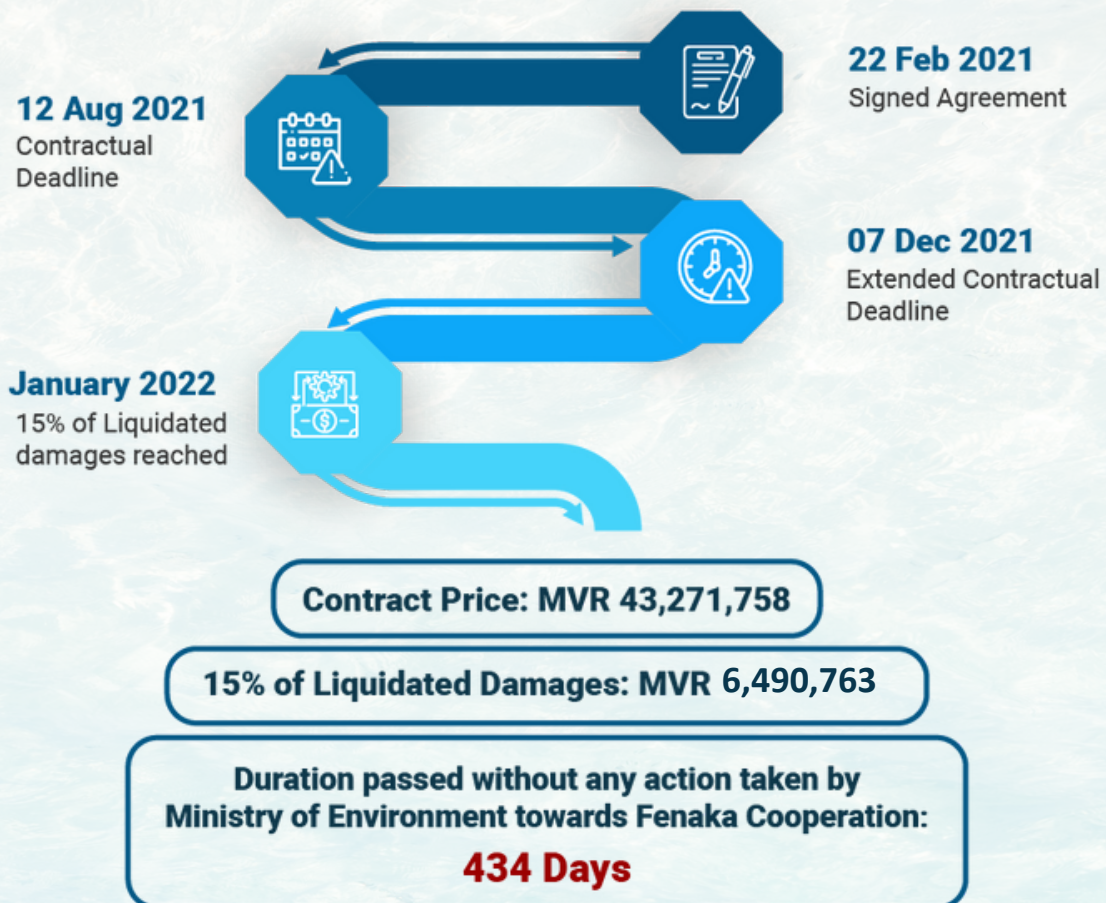
Rectification of Fuvahmulah City Water & Sewerage System

The Rectification Contract worth MVR. 43,271,758 was granted in order to address the ongoing issues within the system and implement a permanent solution. According to the most recent progress report submitted to the Ministry of Environment, it was revealed that only 87% of the contracted work for rectifying Fuvahmulah city's sewerage system was accomplished within the agreed contract period. And at the date of report being issued not all tasks outlined in the rectification project were completed as per the terms and conditions of the contract.

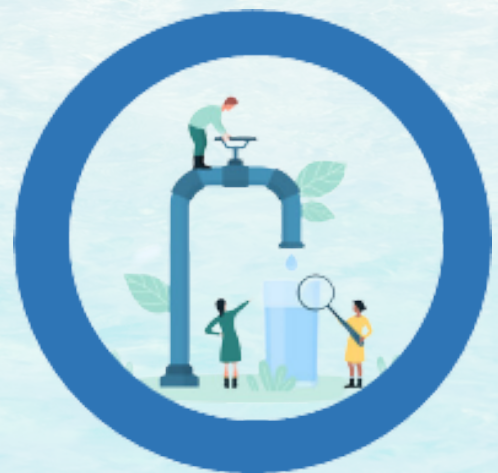
In addition, it is crucial to note that the prevalent contamination in the island's groundwater lens and the overall poor water quality in numerous regions pose a significant hazard to both household appliances and individuals' health as the use of groundwater is preferred for non-potable water uses. Furthermore, the continuous use of groundwater would result a considerable loss of water from the water table to the ocean through the sewer outfall. This water prior to the establishment would be recharged through the septic tanks. If the practice continues, there is risk of groundwater salinization occurring within the island in the future.
