**AUDITOR-GENERAL'S
PERFORMANCE AUDIT REPORT
ON CONSERVATION OF
WATER TOWERS IN KENYA**
BY THE KENYA WATERS TOWERS AGENCY

SEPTEMBER 2023

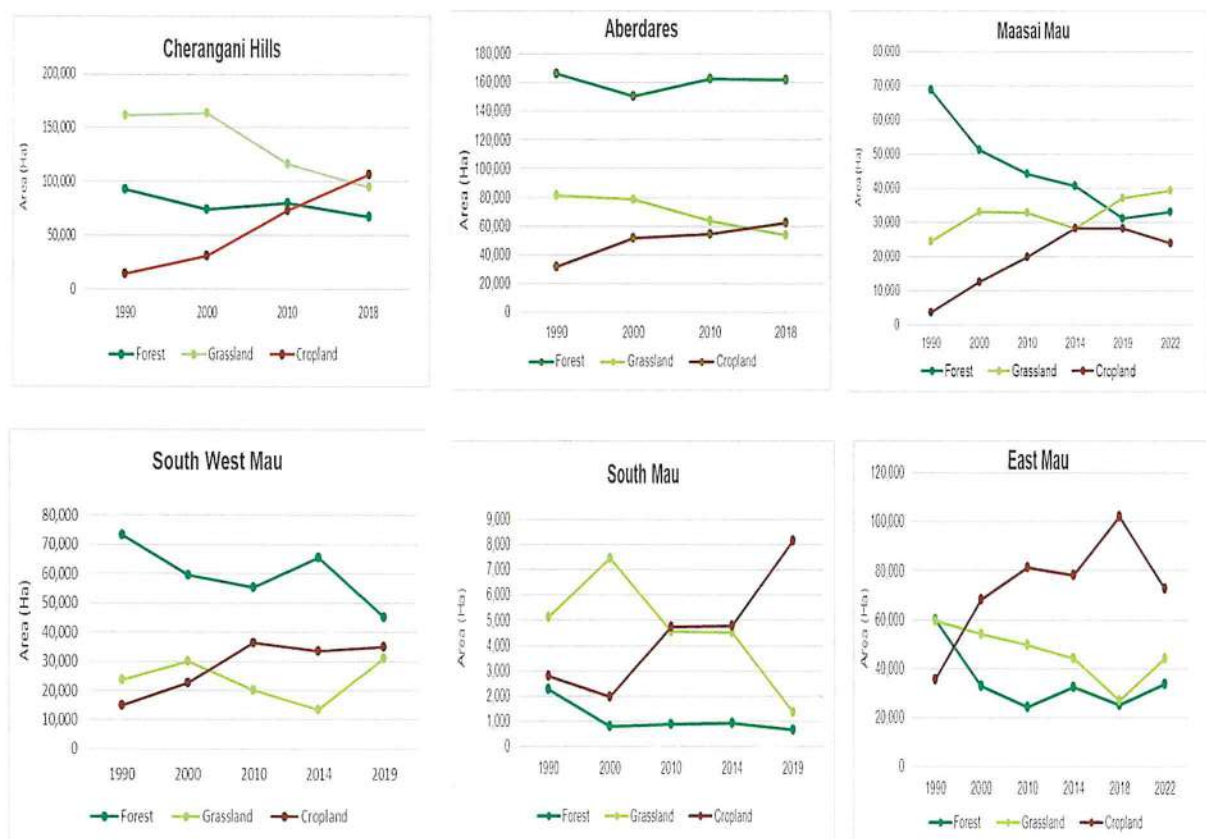
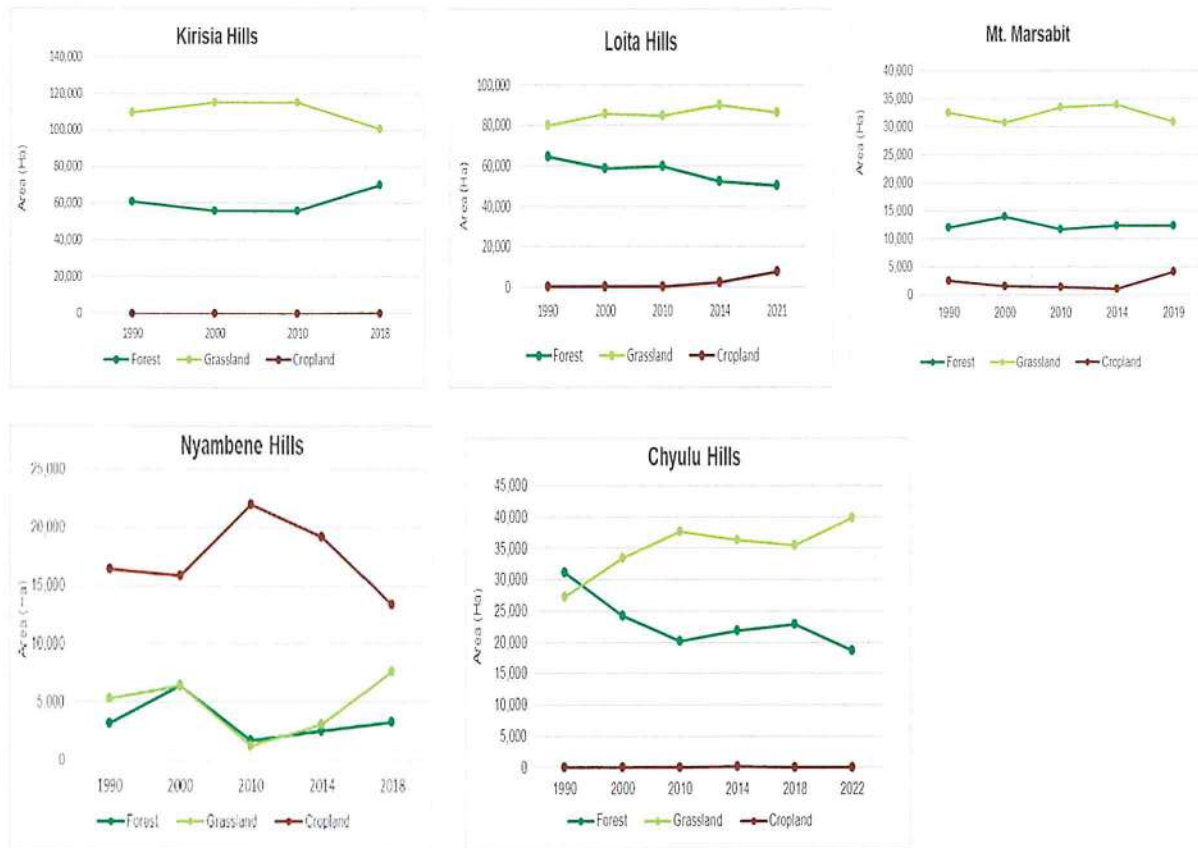
Figure 4: Land Use and Land Cover Changes in the Sampled Water Towers Since 1990

protected forest areas, for settlement and agricultural purposes. For example, review of land use and land cover data, since the year 1990, revealed a declining trend in forest cover in Cherangani, Chyulu, Loita water towers and Maasai Mau, South Mau, and South West Mau blocks as shown in **Figure 4**. The Aberdare Ranges, Cherangani, Loita Hills, Mt. Marsabit water towers and South Mau Block had increased trend in crop land, depicting encroachment. Maasai Mau and East Mau blocks recorded a sharp decline in forest cover with marginal increase since 2019, attributable to rehabilitation activities implemented. Human encroachment into water towers was also observed during physical verifications. For instance, the Embobut Forest Block in Cherangani Hills and Nkareta area in Maasai Mau Block had both human settlement and farming activities. This was observed even on steep slopes thereby increasing the risks of flooding, landslides and siltation of rivers.

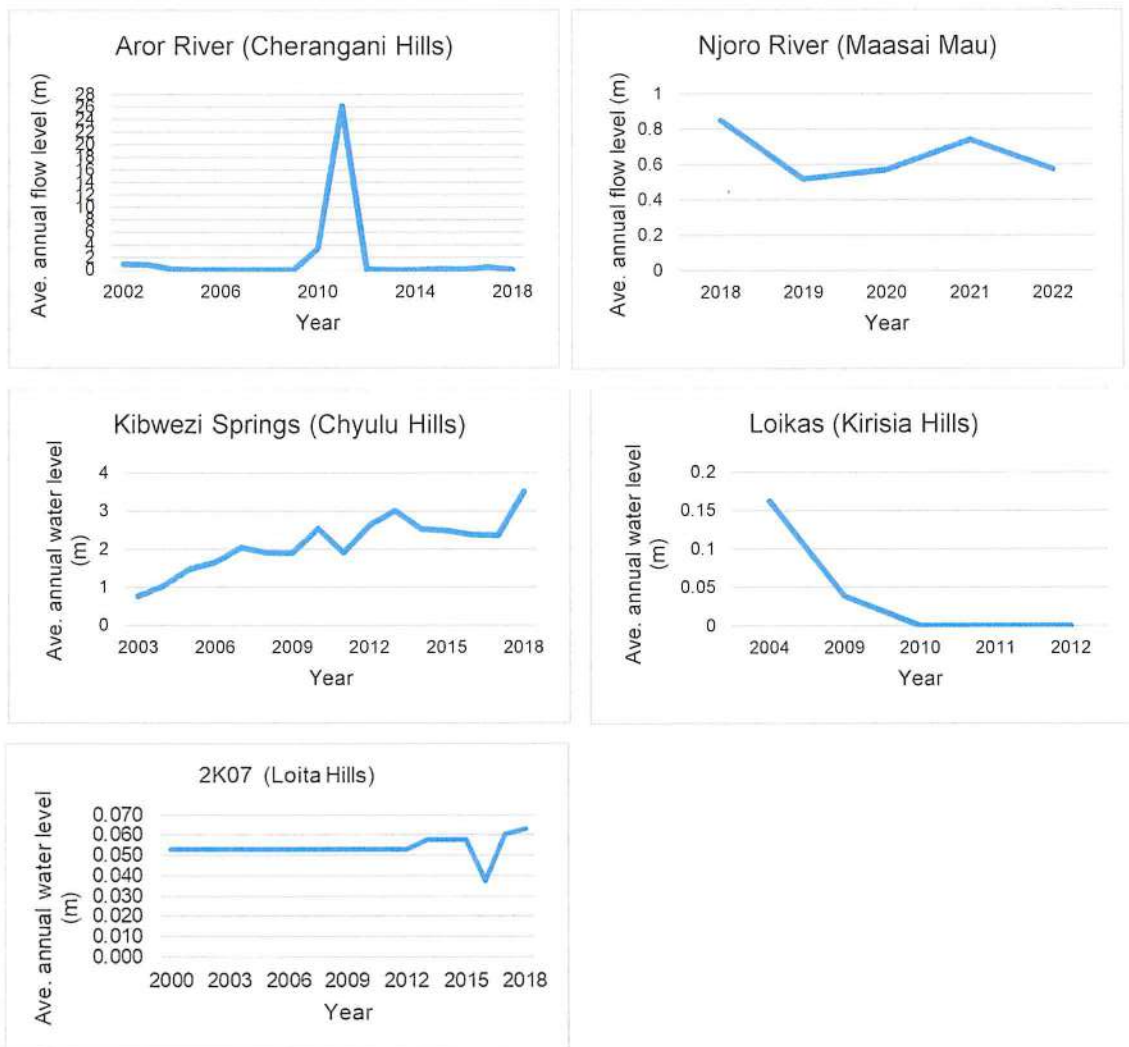
Figure 5: Trend in Water Flow Levels

4.9 The declining forest cover combined with an increase in crop land has had a negative impact on water availability, which contributes to the achievement of SDG 6 Target 1 on universal and equitable access to safe and affordable drinking water for all by 2030. Interviews with staff of the Agency and review of water tower status assessment reports revealed that most of the rivers and springs emanating from these water towers had recorded reduced volumes over the years due to destructive human activities in water towers. This was also confirmed through analysis of water quantity data maintained by the Water Resources Authority (WRA). However, due to limitations in the data, the audit could only confirm the trend in flow levels for water sources in five (5) out of the nine (9) sampled water towers. The data showed a declining trend in three (3) out of the five (5) water sources as shown in **Figure 5**.

- 4.20 Securing of critical water catchment lands is a necessary pre-requisite for conservation of such areas. The limited mapping and securing of such areas denied stakeholders the information needed to prioritize conservation activities and left such lands exposed to destructive human activities. From interviews and document reviews, the audit revealed that critical water catchment areas such as Lake Olbolosat in the Aberdare Ranges, as well as Ol Pusimoru Forest and Enapuipui Swamp in Maasai Mau had experienced some levels of degradation, thereby negatively affecting water availability. For example, analysis of water quantity data revealed a declining trend in Njoro River, whose source is Enapuipui Swamp, as earlier shown in **Figure 5**. Njoro River drains into L.
