Performance audit on Conservation and Ecological restoration of Lakes under the jurisdiction of Lake Development Authority and Urban Local Bodies

GOVERNMENT OF KARNATAKA
Report No.1 of the year 2015

**Performance audit on Conservation and
Ecological restoration of Lakes under the
jurisdiction of Lake Development
Authority and Urban Local Bodies**

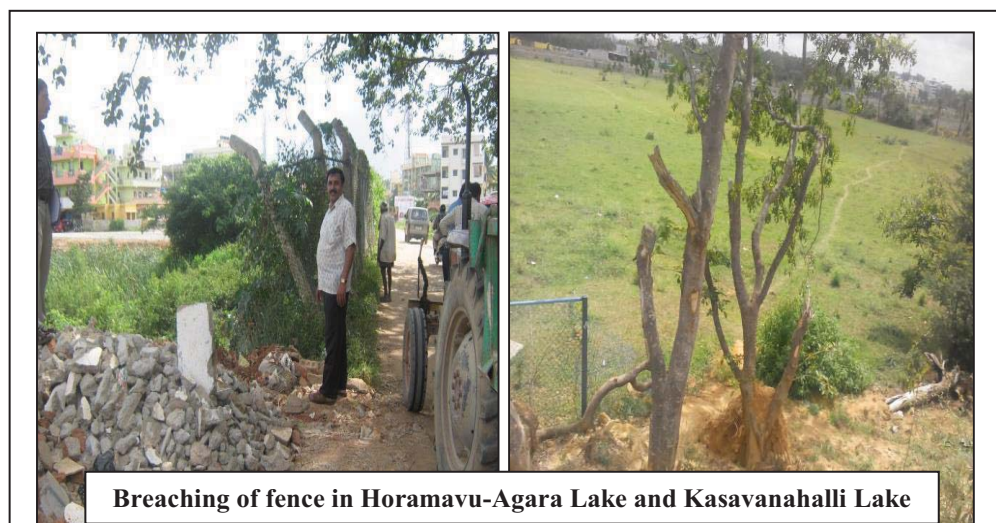
- There were cases of damage caused to fencing around lakes as can be seen from the photographs given below. BBMP had not engaged watch and ward staff in all the restored lakes. BBMP replied (February 2015) that miscreants were entering the lake area and stealing the fence materials. This indicated that there were inadequate security measures for protecting the assets related to the lakes.

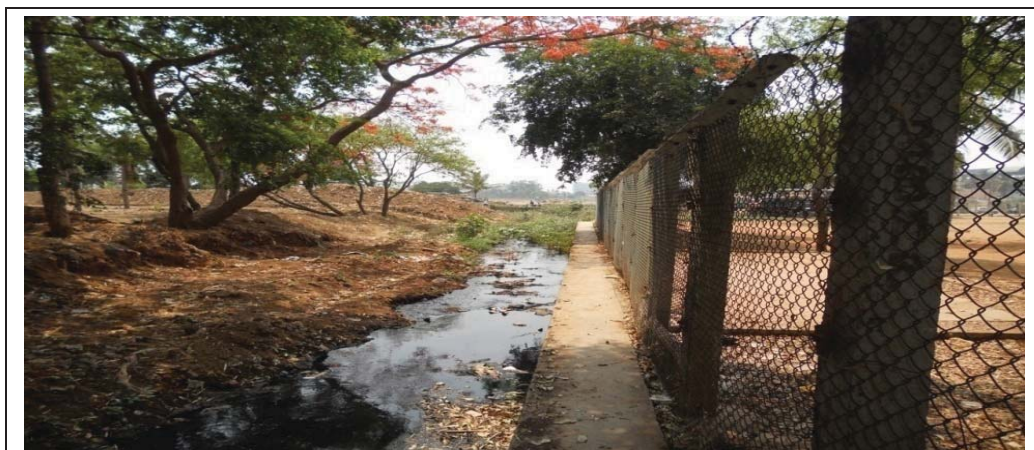
Photograph below taken during JPV also illustrates the level of pollution in a test-checked lake.

Dasarahalli Lake main drain (inlet 1 of the lake) receives all the effluents from Peenya Industrial area as evident from the thick viscous black water flowing in the drain

Recommendation 9: BWSSB should, in coordination with implementing agencies/custodians of the lake, construct STPs and use them optimally to ensure that untreated sewage is not let into the lakes.

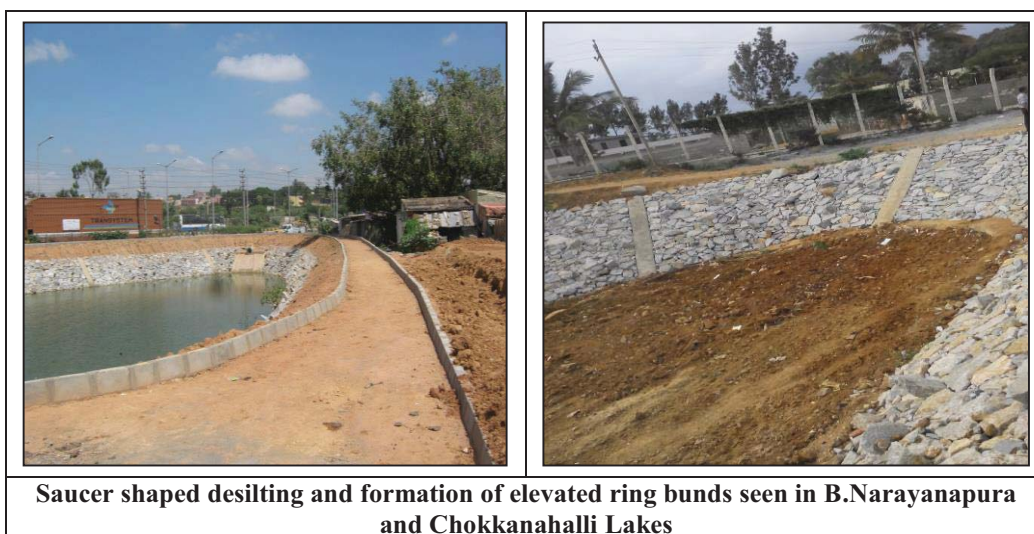
The BDA stated (January 2015) that the deepening of the lake bed was carried out to bring saucer shape to the lake bed. The reply is not acceptable as this was contrary to the expert guidance given (July 2008) by the PCCF. The State Government (UDD) admitted (March 2015) that there was excessive desilting due to accumulation of debris and other wastes in the lakes which was due to delay in the process of preparation of DPRs and execution of the work. Also, slushy soil cannot be used for formation of embankment. The reply is not acceptable as accumulation of debris and other wastes should be avoided once the lake has been handed over to the implementing agencies. For categorising the soil as 'slushy soil', there should be proper soil test reports which were not there. Also, bills showed that that even dry soil was transported out of the lake area. As such, the issue calls for investigation and fixing of responsibility for doing excess excavation as compared with DPRs.

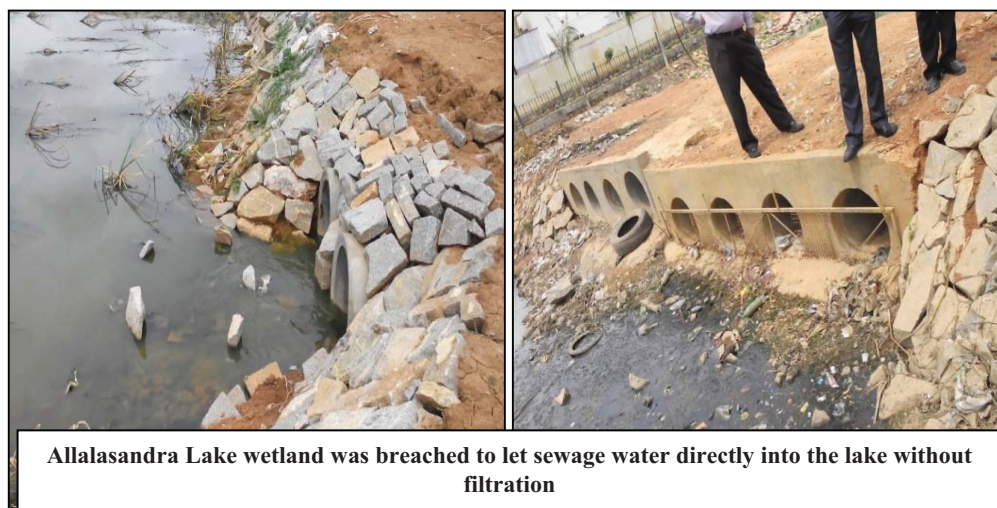
The constructed wetlands were also felt to be insufficient to absorb the pollutants due to absence of aquatic weeds. Due to lack of multilayered slope design in wetland construction, the backlash of sewage to the drain was entering the settlements near the foreshore region, as observed in the case of Allalassandra Lake.

The State Government (UDD) accepted (March 2015) the observation and stated that action would be taken to rectify the breached bunds as well as inlet levels would be ensured in the lakes.

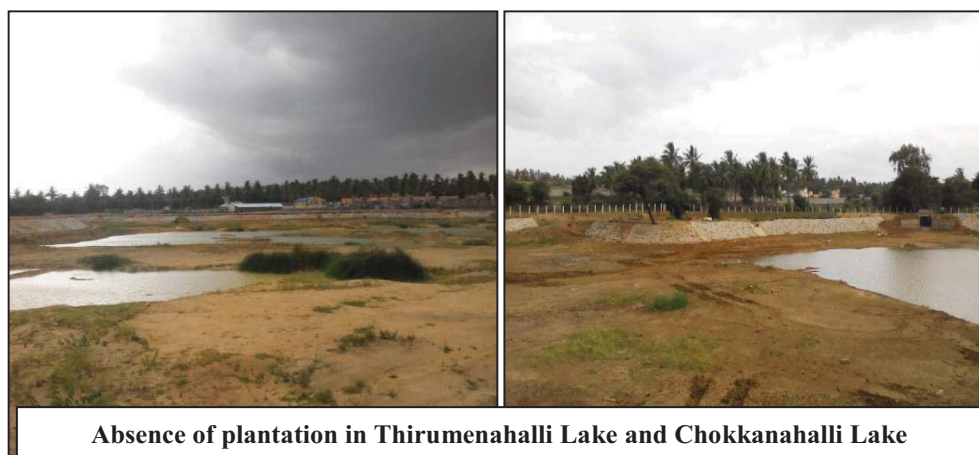
- In two test-checked lakes, Chokkanahalli and Thirumenahalli, the afforestation works were carried out during 2010-11 in the lake bed and thereafter lake rejuvenation works including desilting were done during 2013-14. Audit observed during JPV, that no plantations had survived after the rejuvenation works were carried out. The efforts towards afforestation, therefore, did not yield the intended result.

The State Government (UDD) agreed (March 2015) that the works of afforestation were carried out while fencing works were in progress. This was necessary to bring the evicted area of encroachment under plantation. The reply is not acceptable as these plantation works were destroyed due to desilting and formation of elevated ring bunds in the lake. This resulted in the expenditure incurred on these afforestation works as wasteful.

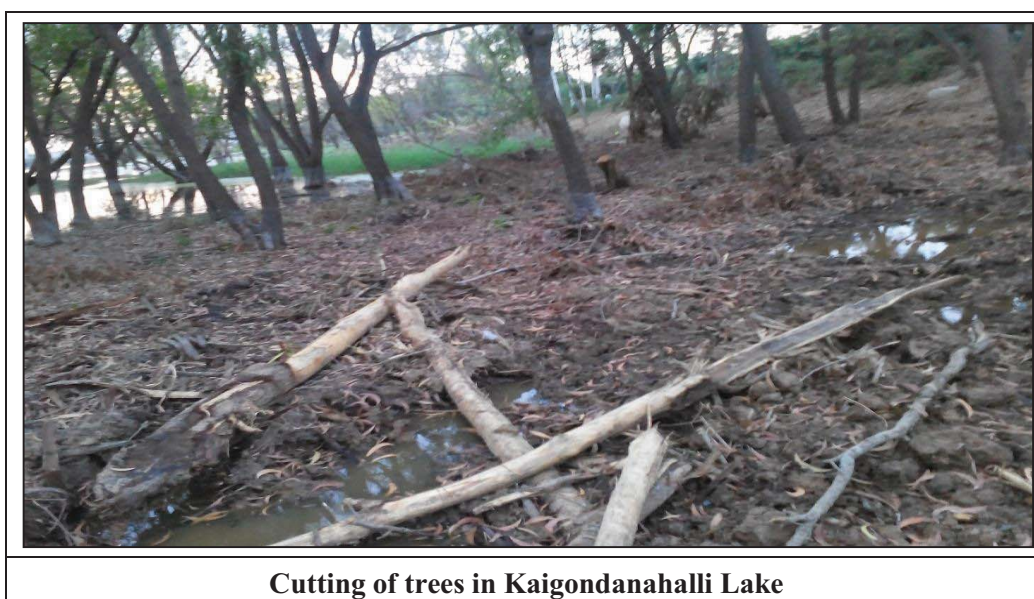
Conversely, during JPV of Kaigondanahalli Lake, Audit observed that trees had been cut indiscriminately to pave way for laying sewage diversion pipe line.

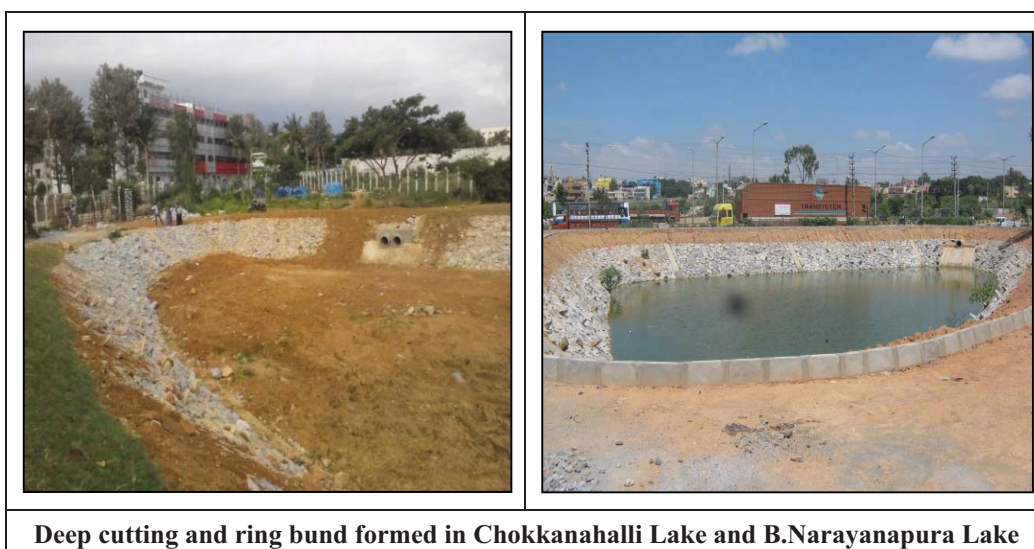
Photographs of such embankment works at Chokkanahalli Lake and B.Narayanapura Lake are given below:

The State Government (UDD) replied (March 2015) that due to urbanisation, vast area was not available for maintaining the foreshore area. The reply is not acceptable as the available foreshore area has been destroyed to create elevated ring bund contrary to the directions issued and could therefore not support the flora and fauna and aquatic life.

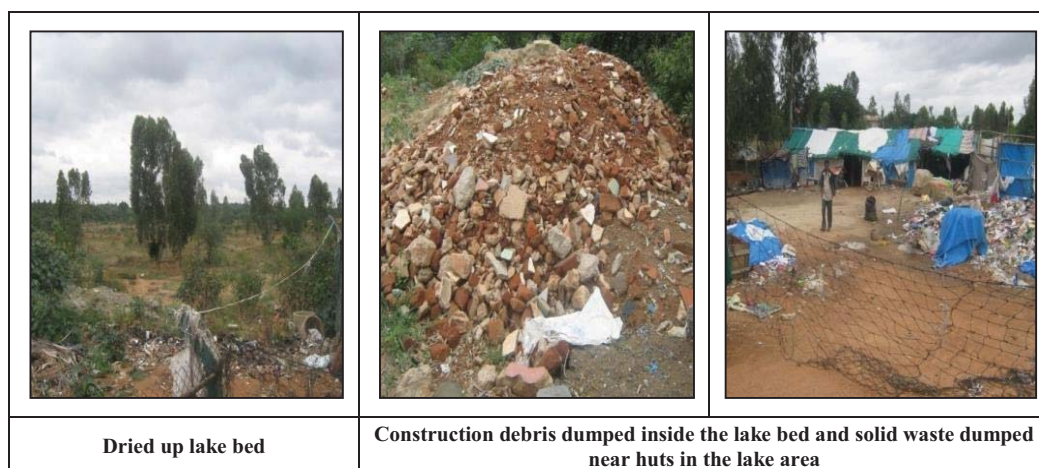
- ❖ The village map and other records revealed that the adjoining Survey.No.63 of Mullur village which was part of the lake is now shown as private land in the latest certified revenue survey map (2010).
- ❖ BBMP had planted trees in the lake bed area and no restoration works were taken up either by BBMP or BDA to revive the lake as a fresh water body.
- ❖ There were no inlets to the lake and thus, the entire lake bed had dried up.
- ❖ Lake was polluted with solid waste and construction debris and the pollution level was also not being monitored by any of the agencies.

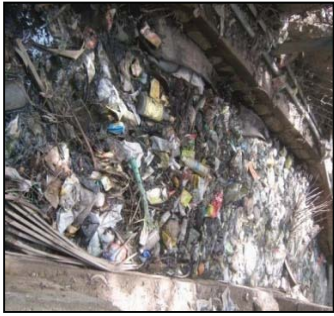
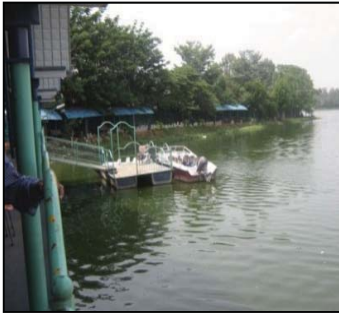
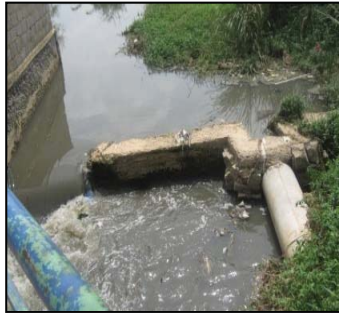
- ❖ A walkway bridge (near Tambuchettypalya Road) was seen damaged, posing danger to the lake users. The LDA replied (April 2015) that walkway bridge had been repaired.

Lake area with solid waste	Motor boats in lake area	Inlet from STP side bringing polluted water

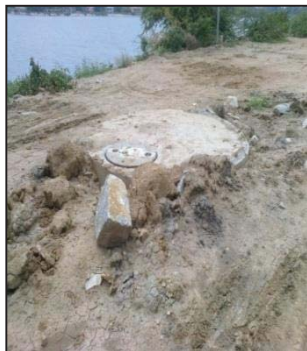
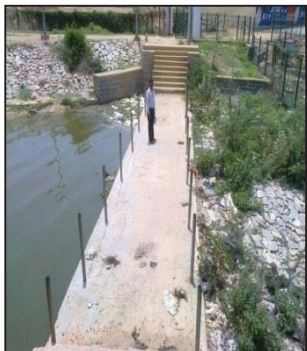
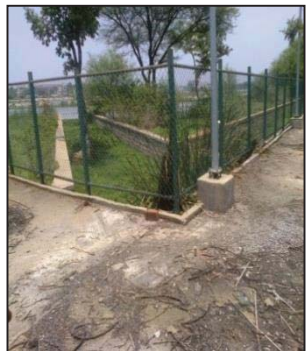
- ❖ Restoration works carried out without removal of encroachments.
- ❖ BDA had formed a residential layout in the lake area. It also irregularly diverted 11 acres of lake for formation of park as part of rejuvenation works in violation of rules.
- ❖ Fencing was breached and left open in many stretches to provide access roads to the nearby residential areas.
- ❖ The level of pollution was not assessed by any agency. BWSSB laid UGD network very close to the water spread area with the approval of LDA and BDA.
- ❖ The treated water flowing from Jakkur Lake was not entering the lake as the inlet was connected to sewage diversion channel and wetland remained dry.

BWSSB trunk sewer chamber close to the water spread area	Lowered waste weir without flow	Constructed wetland without any water

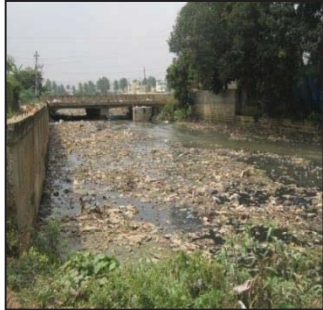
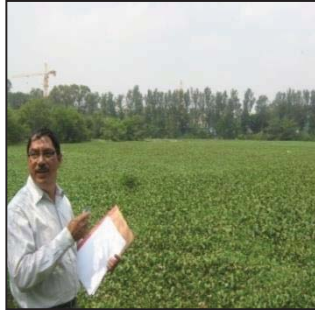
- ❖ The lessee had provided restaurants, party halls, amusement and water theme parks, motor boats *etc.*, thereby polluting the lake area. Due to sewage ingression, the entire wetland region was covered with water hyacinth and floating debris. The level of pollution was not assessed by any agencies. LDA replied (April 2015) that action would be taken to improve the ecological health of the lake.

Sewage with floating debris from SWD entering the lake	Formation of Special Economic Zone in the Buffer zone	Wetland fully covered with water hyacinth and weeds

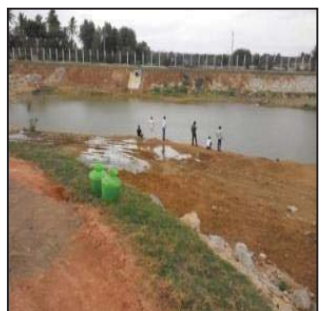
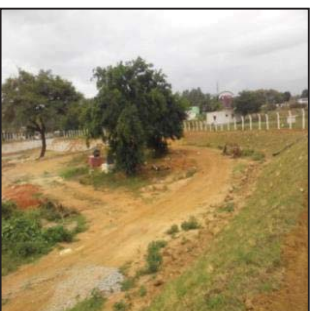
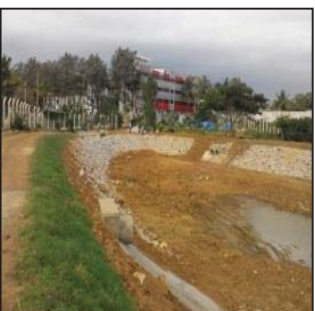
- ❖ The *atchcut* area across the main bund had been demarcated for residential site formation.
- ❖ The lake bund was used as a road to provide connectivity to the nearby areas.
- ❖ During JPV, a graveyard was noticed inside the lake area. Local people were fishing in the lake.
- ❖ The constructed inlet was defective as the opening of inlet was below the existing waste weir. The inlet provided with silt trap, screen barrier *etc.*, was clogged and the excess water was not flowing into the lake.
- ❖ The pollution level was not being monitored by any of the agencies.

Fishing in the lake	Graveyard inside the lake	Inlets opening to the lake below the level of waste weir

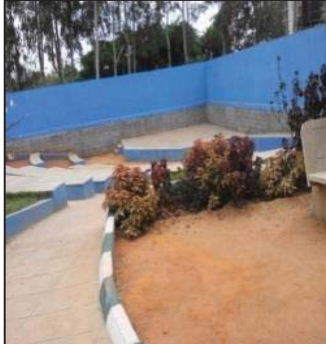
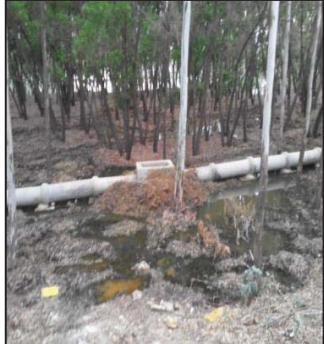
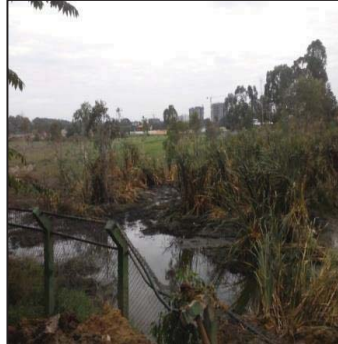
- ❖ The Sarjapura main road is passing through the lake bund, thereby reducing the lake area.
- ❖ Natural flow of rain water/storm water had been restricted to flow through pipeline due to the formation of ring bund.
- ❖ Sewage diversion line was laid inside the water spread area by cutting trees.
- ❖ The foreshore area on the southern part of the lake was being developed into residential complex, breaching the buffer zone.
- ❖ An open amphitheatre was constructed in the lake bed, reducing the lake area.
- ❖ KSPCB (November 2013) classified the quality of water of lake as “E” category, which was below the prescribed standard “B” for outdoor bathing in developed lakes.
- ❖ An NGO (MPSMAS) had taken up the responsibility to maintain the lake.

Amphitheatre inside the lake	Diversion pipeline laid inside lake	Loss of foreshore area due to formation of ring bund in the lake

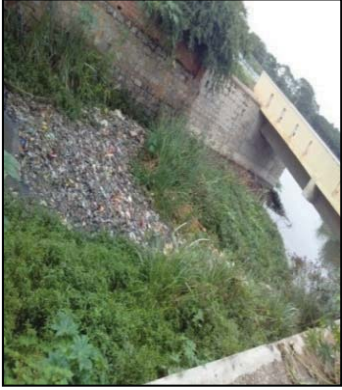
- ❖ The silt traps/sedimentation tanks were blocked, thus disallowing any inflow into the lake and instead the *Raja Kaluve* (SWD) with sewage and solid waste was flowing from the surrounding settlements into the lakes, thereby polluting the lake.
- ❖ The pollution level was not being monitored by any of the agencies.

<p>Removed weeds dumped alongside the pathway</p>	<p><i>Raja Kaluve</i> with sewage and solid waste</p>	<p>Blocked silt traps/sedimentation tanks without water entering the lake</p>
